# Oregon DEQ Solid Waste Disposal Facility Inspection Form

**FACILITY:** Croman Mill Site

**INSPECTION DATE:** 8/20/19

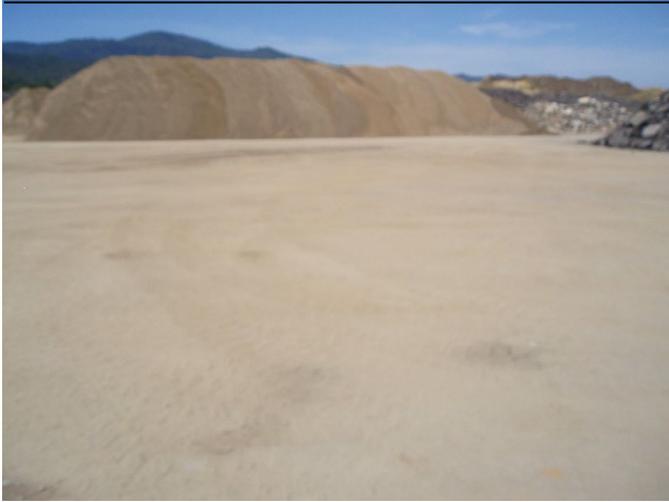
Pile of clean granite and other sorted materials.

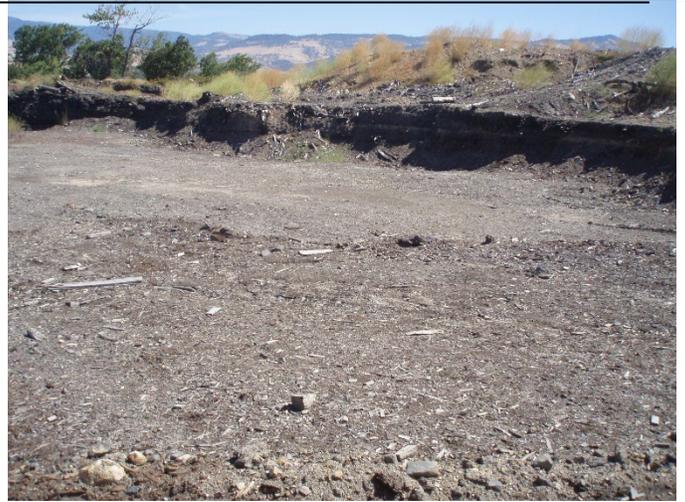
One active dig area. Material is about 40% rock and 60% wood.

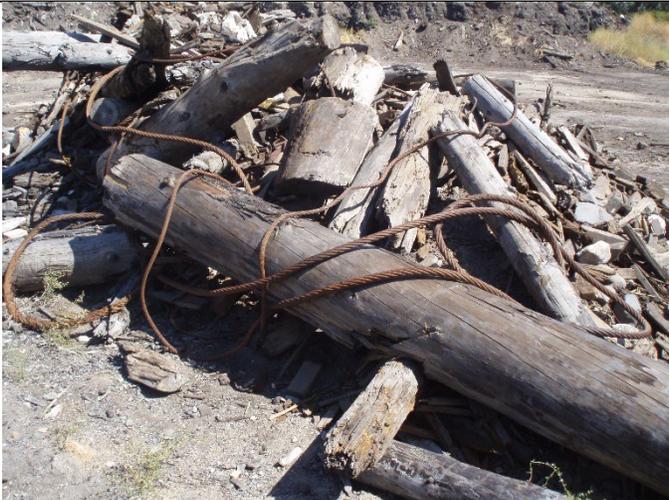
Large woody material to be used as hog fuel or ground into bio-mass fuel.

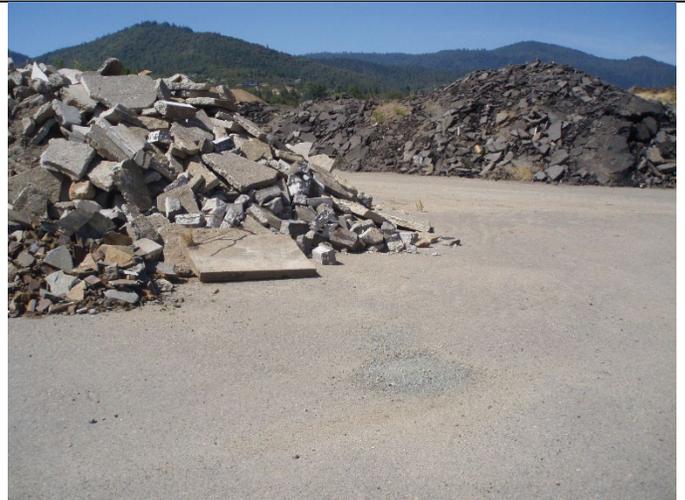
Sorted concrete being reclaimed for clean-fill, and asphalt for recycling into new asphalt.

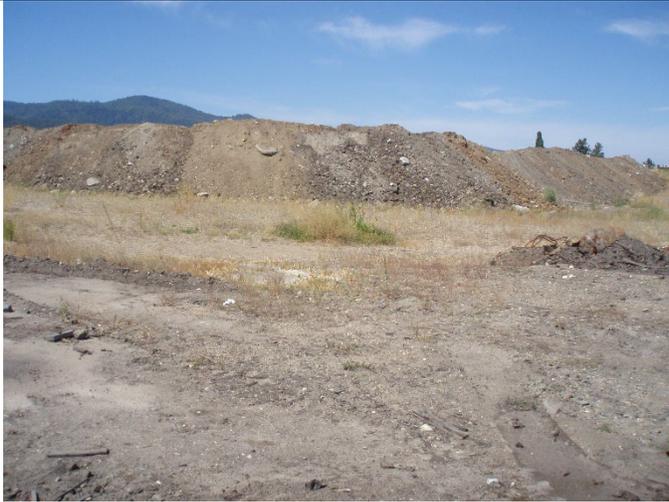
Stockpiled clean soil for backfilling.

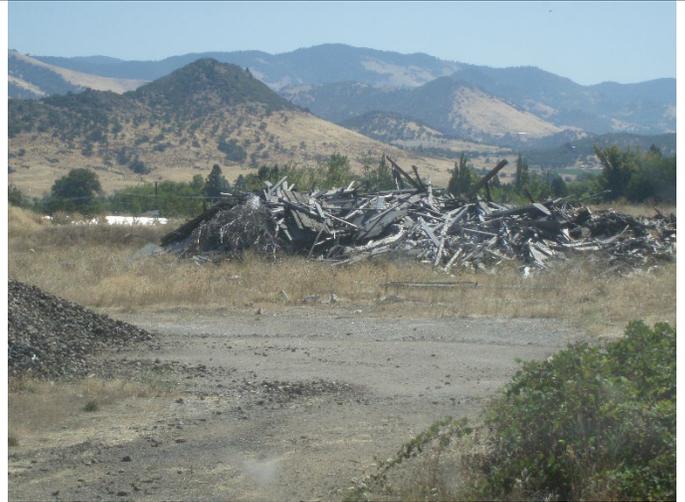
Remnants of demolished mill building awaiting processing.

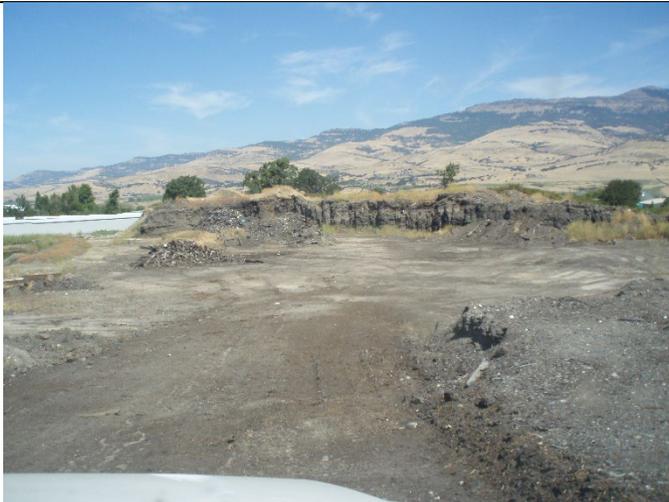
Portion of old landfill area now down to original grade/soils.

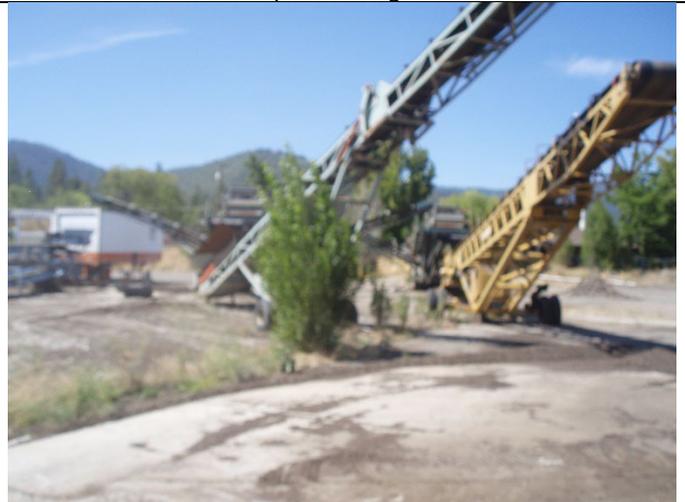
Screening equipment used to process the various materials.
