# Oregon DEQ Solid Waste Disposal Facility Inspection Form

**FACILITY:** Croman Mill Site

**INSPECTOR NAME:** David Esch

**INSPECTION DATE:** 5/1/15

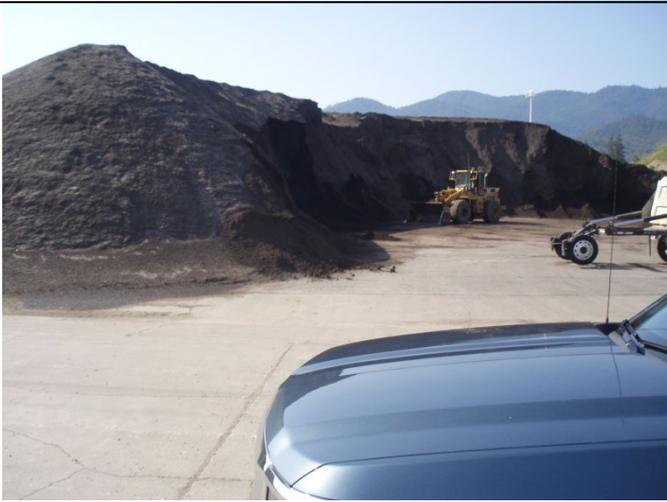
Finished soil amendment ingredient.

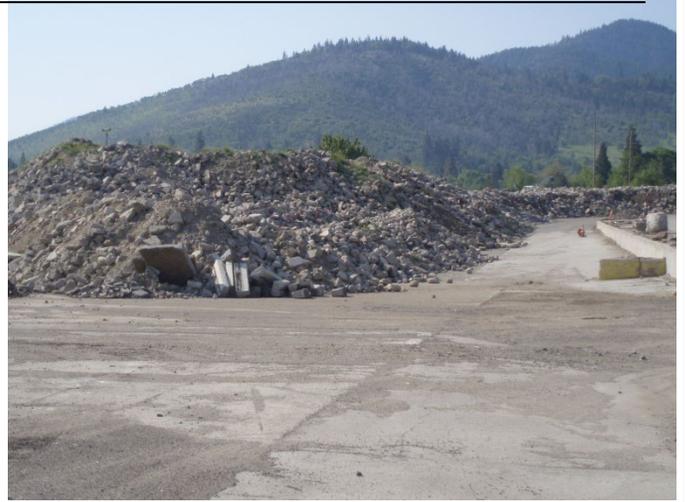
Partially sorted material. About 1/2 rock and 1/2 wood.

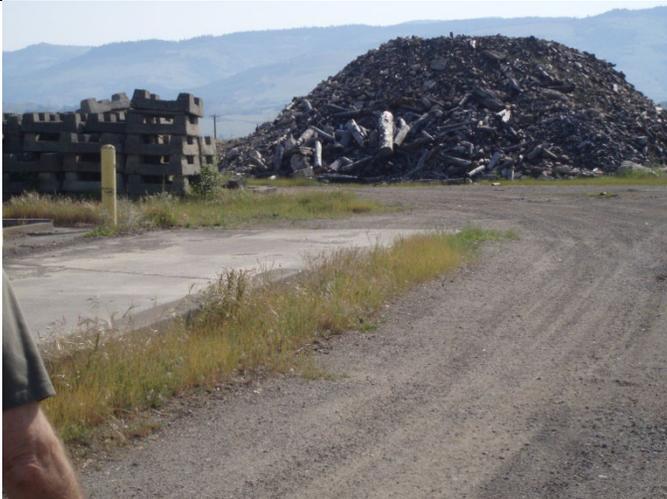
Large woody materials.

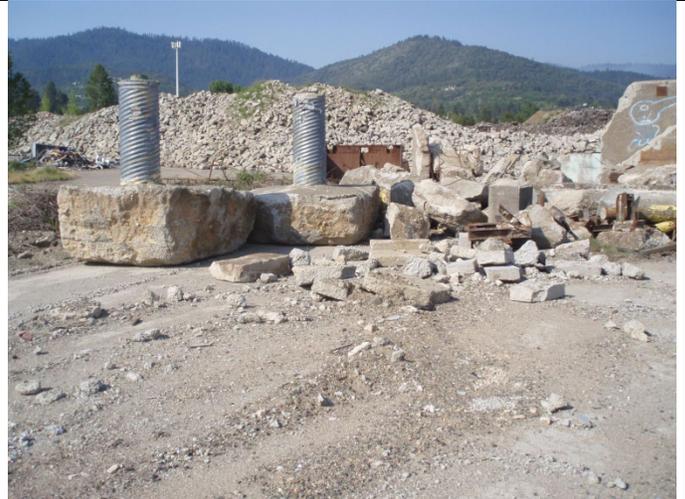
Concrete being reclaimed for clean-fill.

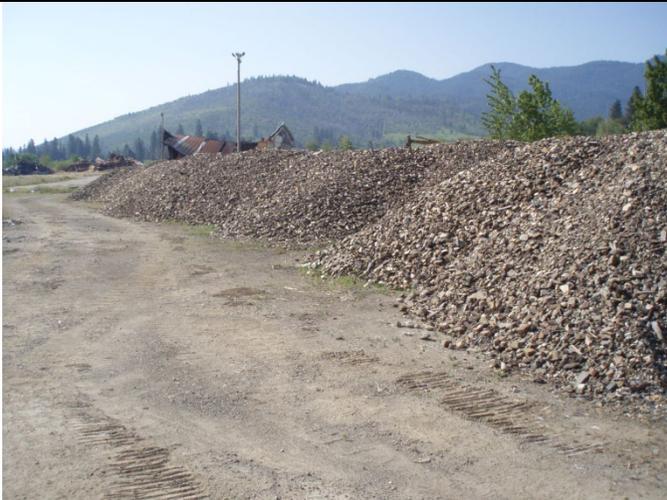
Salvaged rock for re-use.

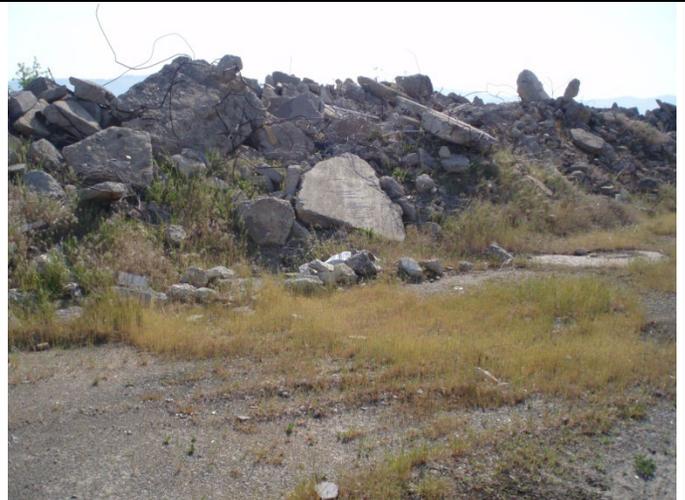
Salvaged asphalt for recycling.

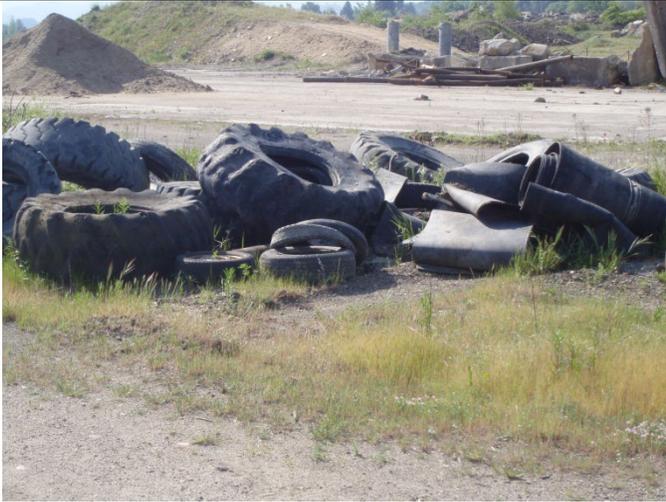
Tires/rubber segregated for disposal.

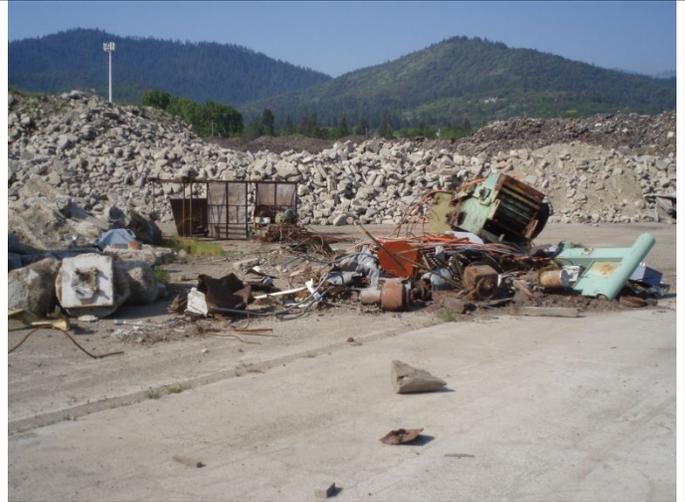
Scrap metal sorting area.

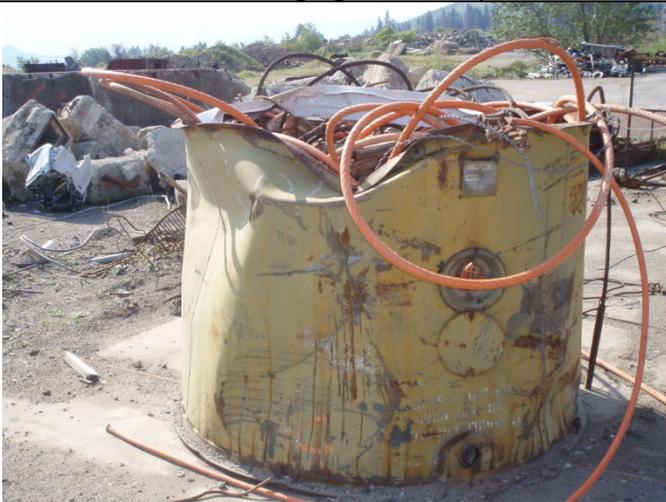
Wiring and metal cables.

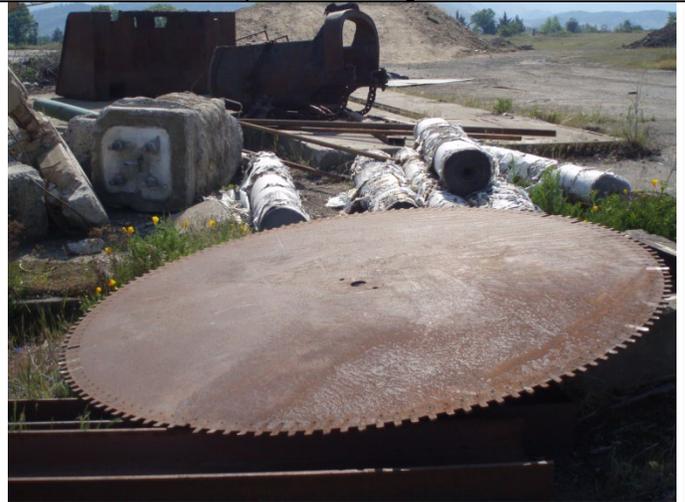
Items requiring special treatment for recycling.

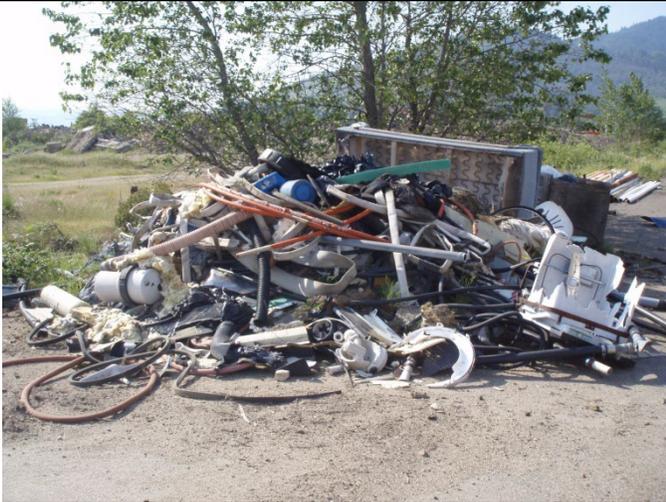
Pile of garbage ready for disposal.

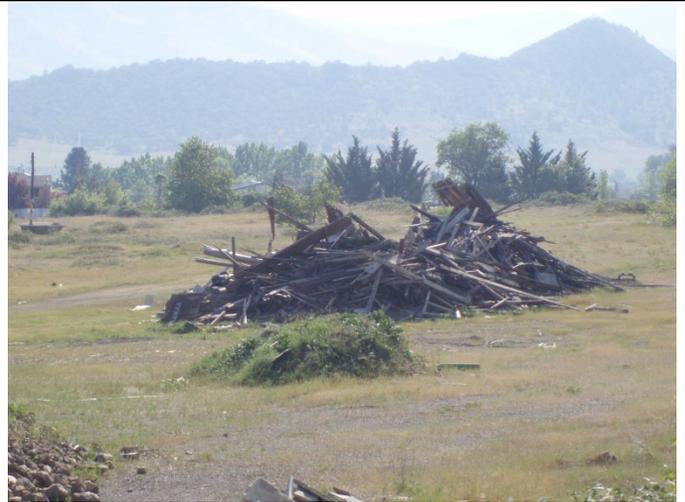
Demolition debris slated for Bio-Mass1.

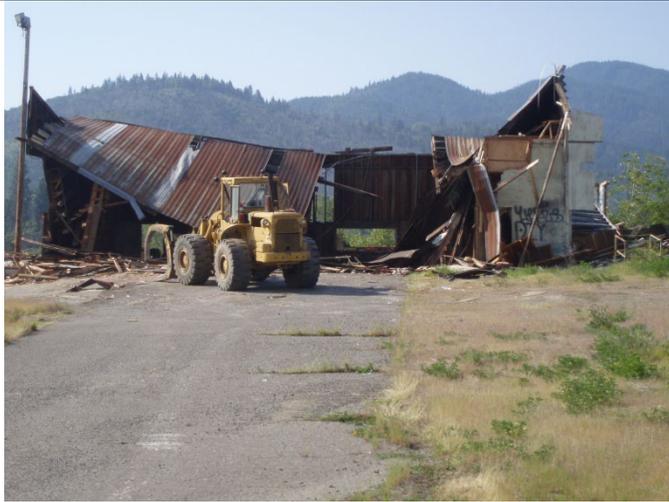
Demolition of last remaining structures.

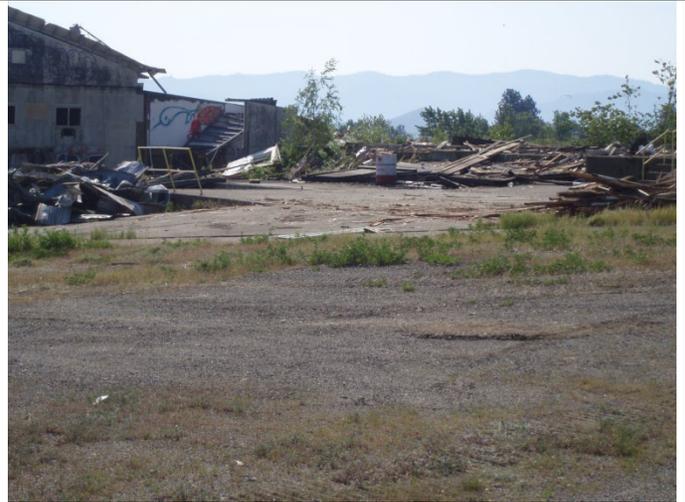
Another view of building demolition.

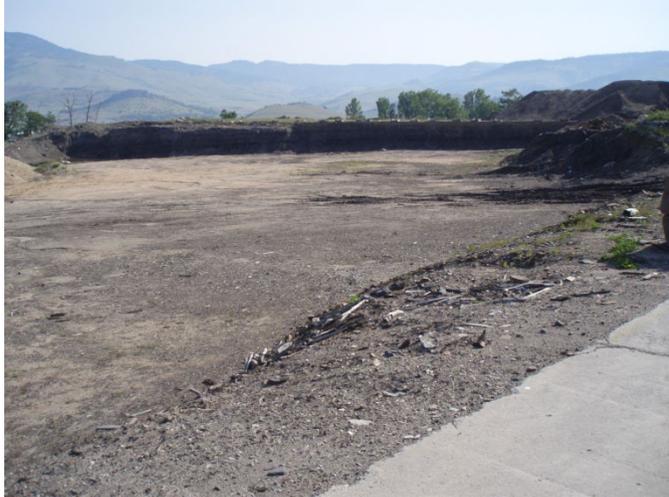
Old landfill area now down to original grade/soils.

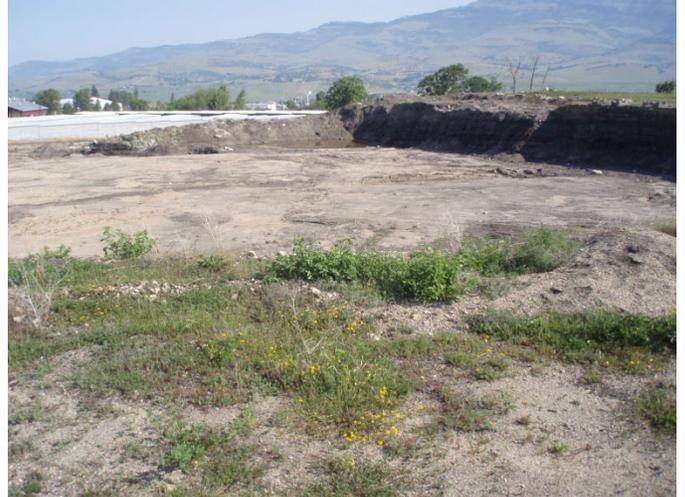
Another view of excavation area.

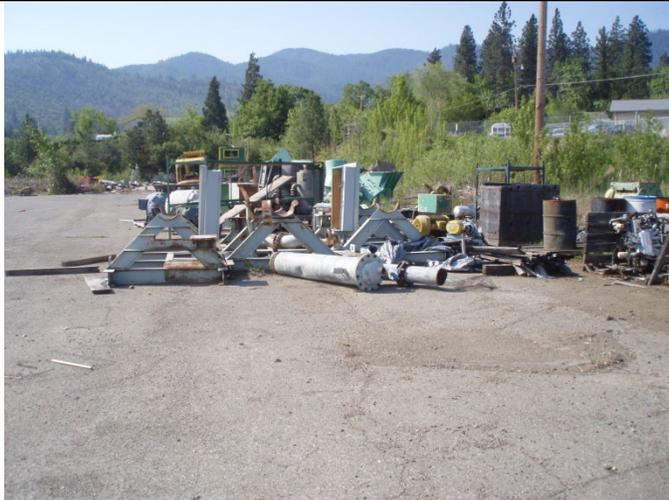
Bone-yard for old mill equipment.

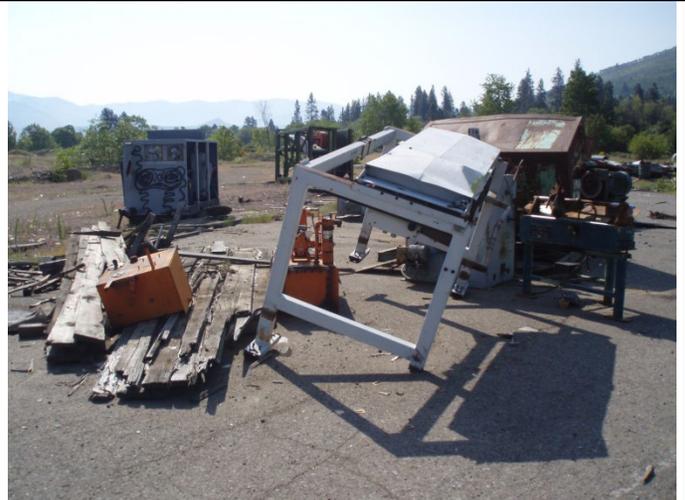
Additional equipment awaiting its fate.
