City of Ashland FCA

PUBLIC WORKS, PARKS, AND REC

ASHLAND, OR

JUNE 26, 2024

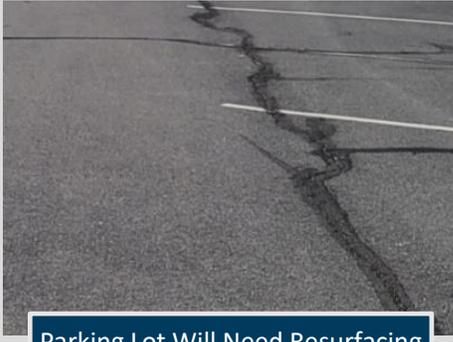
Parking Lot Will Need Resurfacing
