**Facility Planning Optimization & Management Plan**  
for the City of Ashland, Oregon  
2025

# Facility Condition Assessment Executive Report

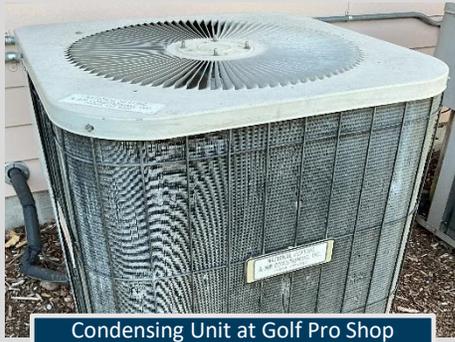
Most envelope components of the building are original, with minimal wear issues observed. However, the wood fascia and soffit of the roofs on the Golf Pro Shop and the Golf Cart Barn both display signs of weathering that necessitates attention and repainting to prevent dry rot. The golf cart barn additionally was observed with minimal debris in its gutters and some moss growing on its roof. The installation of gutter guards could extend the life of the gutters and therefore the building while also cutting costs associated with cleaning them. Minimal rust was observed on the metal frame of the doors to the exterior storage closet of the Maintenance shop, warranting attention.

Condensing Unit at Golf Pro Shop Beyond Useful Life Expectancy.
