SCHOTT & ASSOCIATES, INC.
Ecologists & Wetland Specialists

**JURISDICTIONAL WETLAND
DELINEATION REPORT
FOR**

Croman Mill Redevelopment Project

April 2024

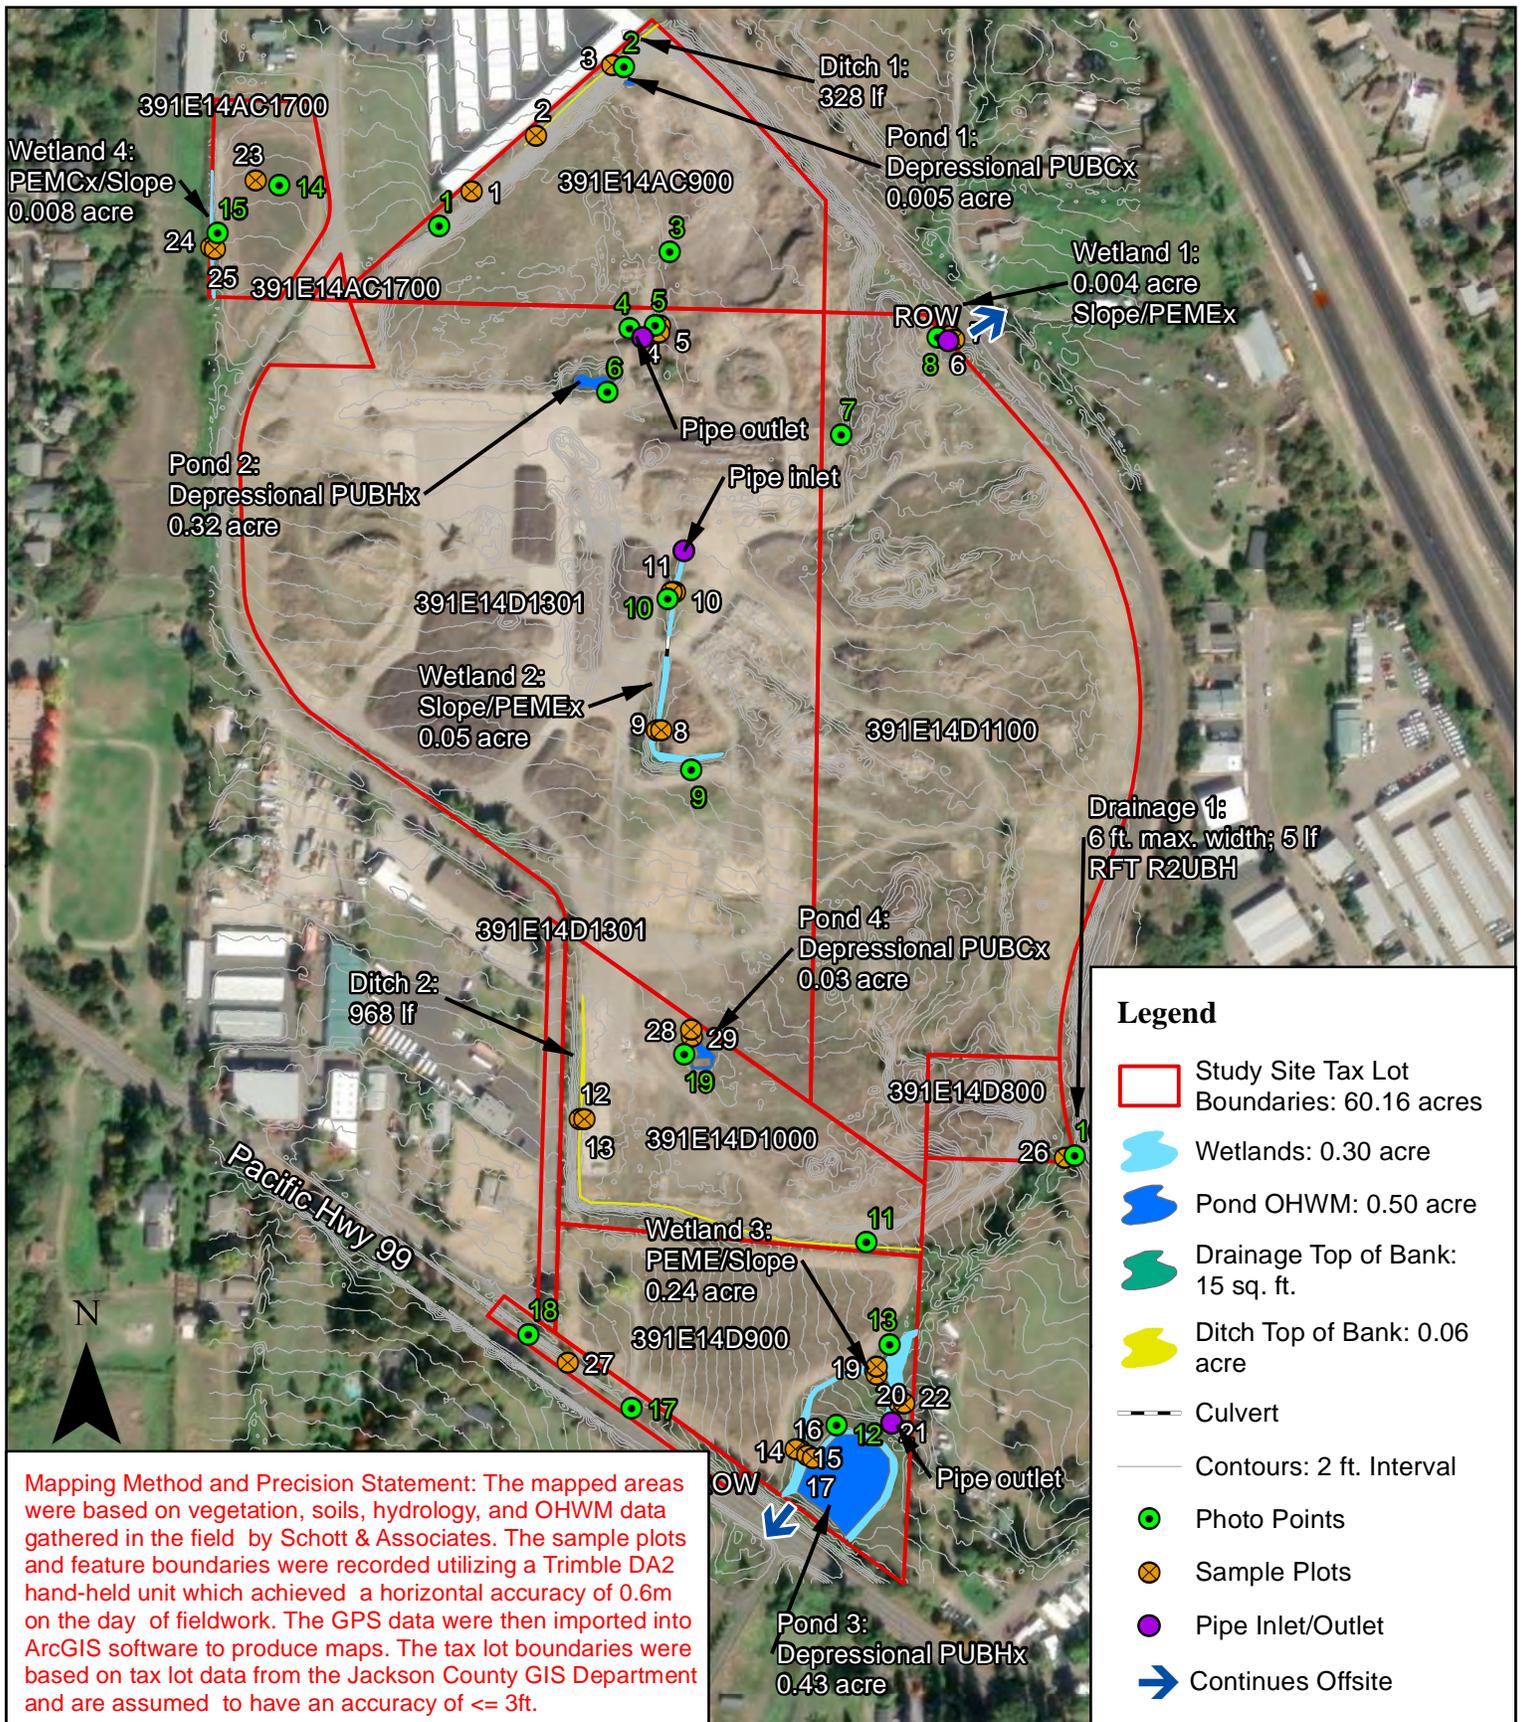
Figure 6a. Wetland Delineation Map - Overview

Excavated Pond 4 (0.03-acre; PUBCx): Pond 4 was located in the southern half of the study site, north of Ditch 2. This feature was man-made, excavated, and appeared to be associated with the removal of a building. The pond had more than two feet of water at the deepest end, with vegetation in the water dominated by common spikerush (*Eleocharis palustris*; OBL) and some cattail (OBL). Small (<12 ft) cottonwood (*Populus balsamifera*; FACW) and willow (*Salix* sp.; FAC or wetter) were also observed. A sample plot was established in the shallow end of the pond and was dominated by hare barley (*Hordeum murinum*; FAC). Soils met the depleted matrix (F3) Corps hydric soil

Wetland 4 (0.008-acre; PEMCx): Wetland 4 was located along the northwestern site boundary. The feature appeared to be within a private excavated irrigation lateral. The ditch extends downslope from south to north. Onsite, the ditch was predominantly covered in a blackberry thicket with a few patches of cattail, and reed canarygrass (*Phalaris arundinacea*; FACW). Soils met the F6 hydric soil indicator. No primary wetland hydrology indicators were observed at the time of the site visit. Secondary indicators included drainage patterns (B10) and geomorphic position (D2). The feature met all wetland criteria and was mapped as a wetland ditch. It is assumed this feature flows seasonally to service irrigation flow for the neighboring property to the west.

Ditch 1 (0.01 acre; 328 lf): Ditch 1 was an excavated ditch along the northern property boundary (Photo Point 2) which originated onsite and sloped gently northeast to the offsite railroad ditch. The ditch was vegetated by upland grasses and was dry at the time of the site visit. A high-water table was present at the eastern (lower) end of the ditch, but hydric soil indicators were not present. No evidence of recent flow or surface water was observed.

Ditch 2 (0.05 acre; 968 lf): Ditch 2 was an excavated feature running south and then east along TL1000. Ditch 2 was constructed from upland as part of sawmill operations to intercept overland flow from extending south. The ditch was vegetated in patches by cattail or predominantly open water/bare. At the time of the site visit two inches of surface water were present. Hydric soil indicators were not observed.

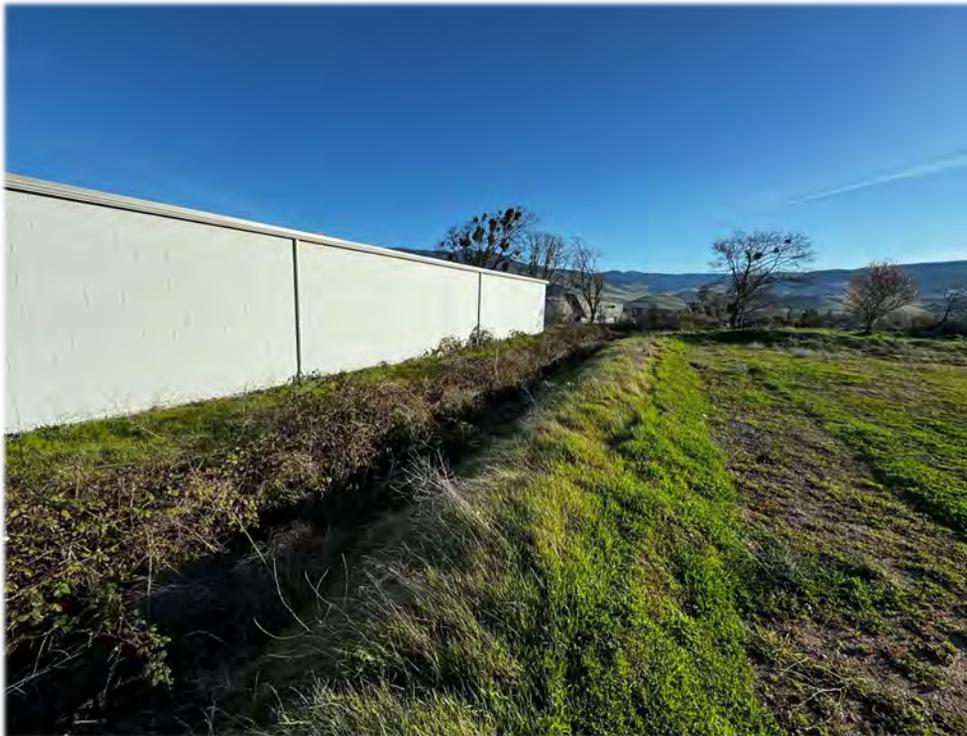
Photo Point 2. Facing northeast, showing Ditch 1.

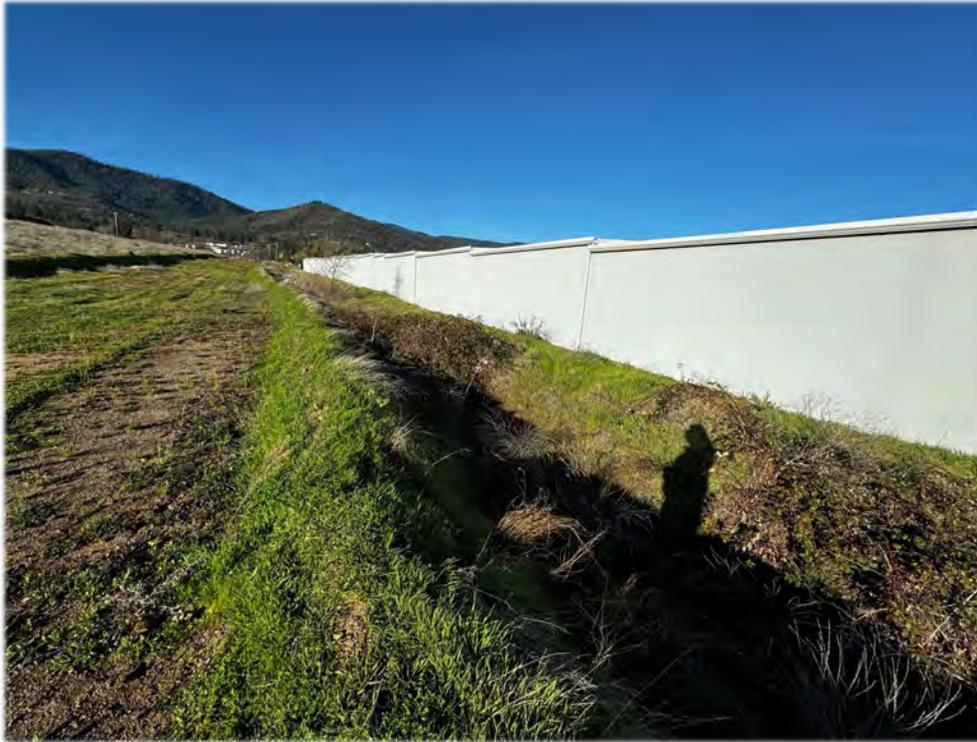
Photo Point 2. Facing southwest, showing Ditch 1.

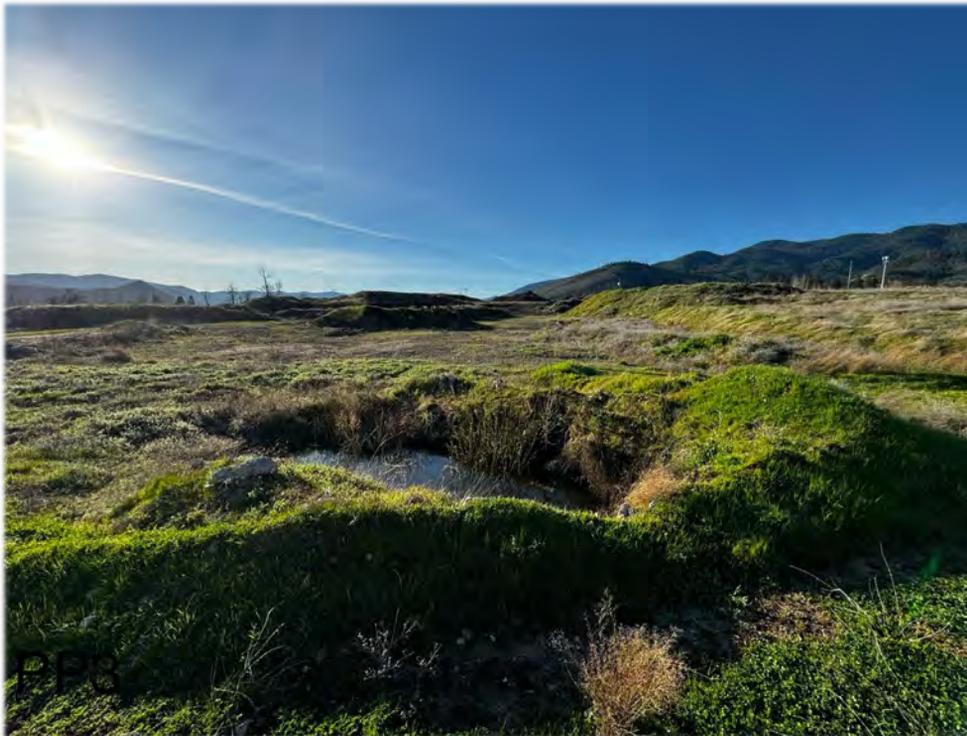
Photo Point 2. Facing south, showing small manmade pond.

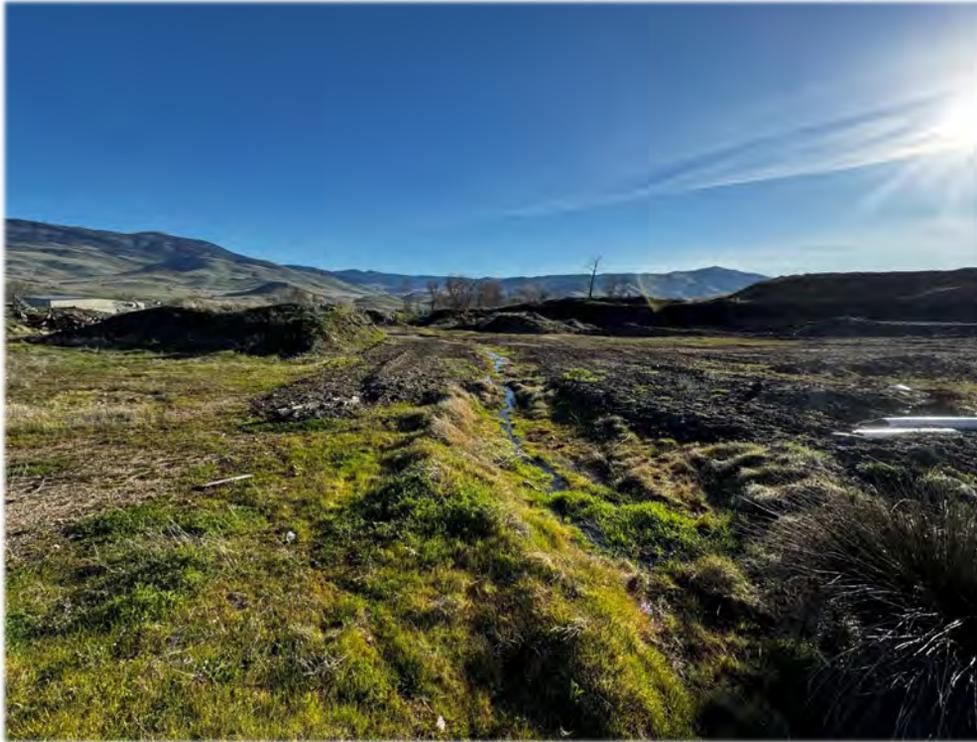
Photo Point 3. Facing northeast, showing surface water extend northeast across the site. Surface water is associated with a leaking pipe to the southwest (near PP4).

Remarks: Area is historically very disturbed. A leaking pipe was supplying water to this area. Assuming the pipe can be repaired/fixed, this area would likely no longer have hydrology indicators.

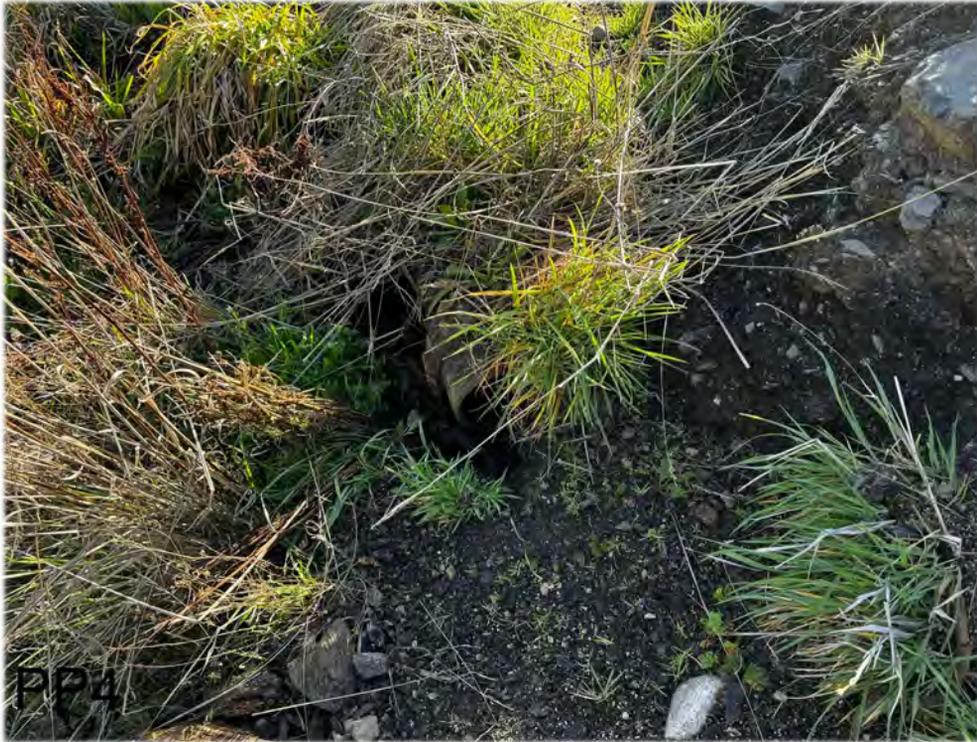
Hydrophytic Vegetation Present?	Yes _____ No <u>x</u>	Is the Sampled Area within a Wetland?	Yes _____ No <u>x</u>
Hydric Soil Present?	Yes _____ No <u>x</u>		
Wetland Hydrology Present?	Yes _____ No <u>x</u>		
Remarks: Plot is paired upland plot in an area that is leaking water.

Photo Point 4. Showing pipe that is leaking water. Pipe associated with a water system throughout the site, associated with historic sawmill operations.

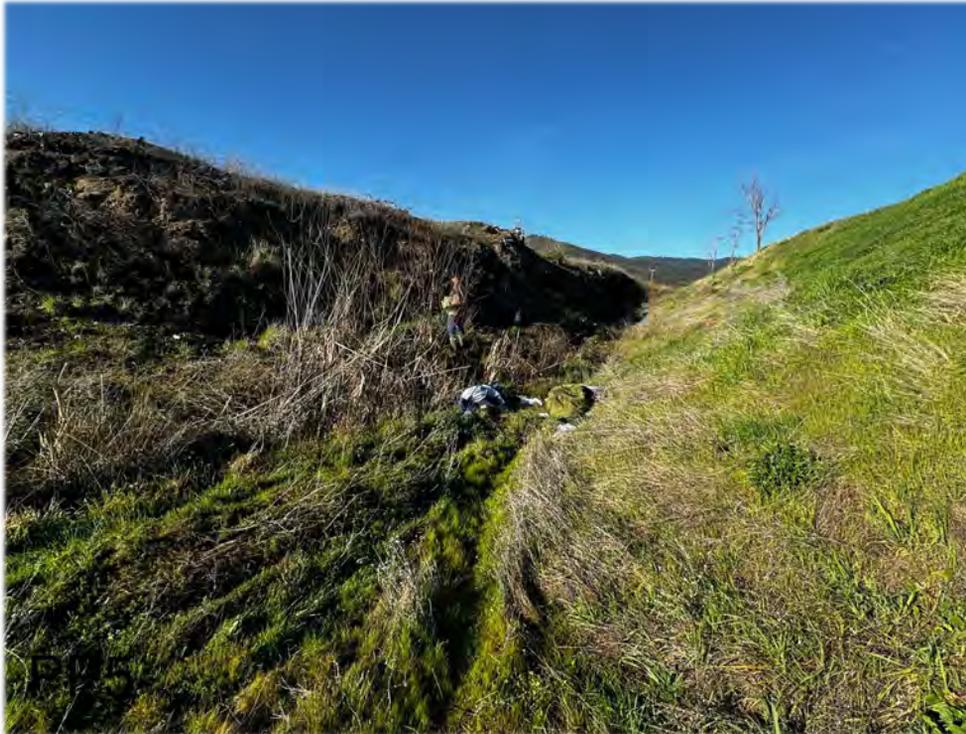
Hydrophytic Vegetation Present? Yes <u>x</u> No _____ Hydric Soil Present? Yes _____ No <u>x</u> Wetland Hydrology Present? Yes <u>x</u> No _____	Is the Sampled Area within a Wetland? Yes _____ No <u>x</u>
Remarks: Plot placed in a wet/saturated area. Water source is a leaking pipe allowing water to flow through the flat terraced area, then to the north and northeast toward the railroad right of way.

Photo Point 5. Facing southwest, toward leaking pipe.

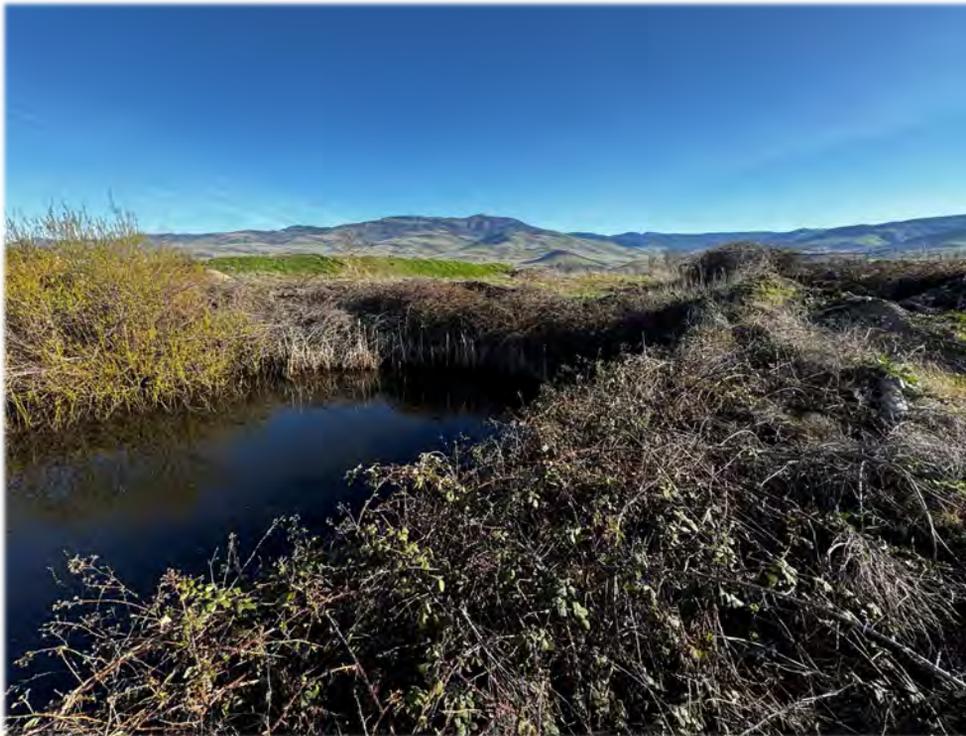
Photo Point 6. Facing north, showing man made pond.

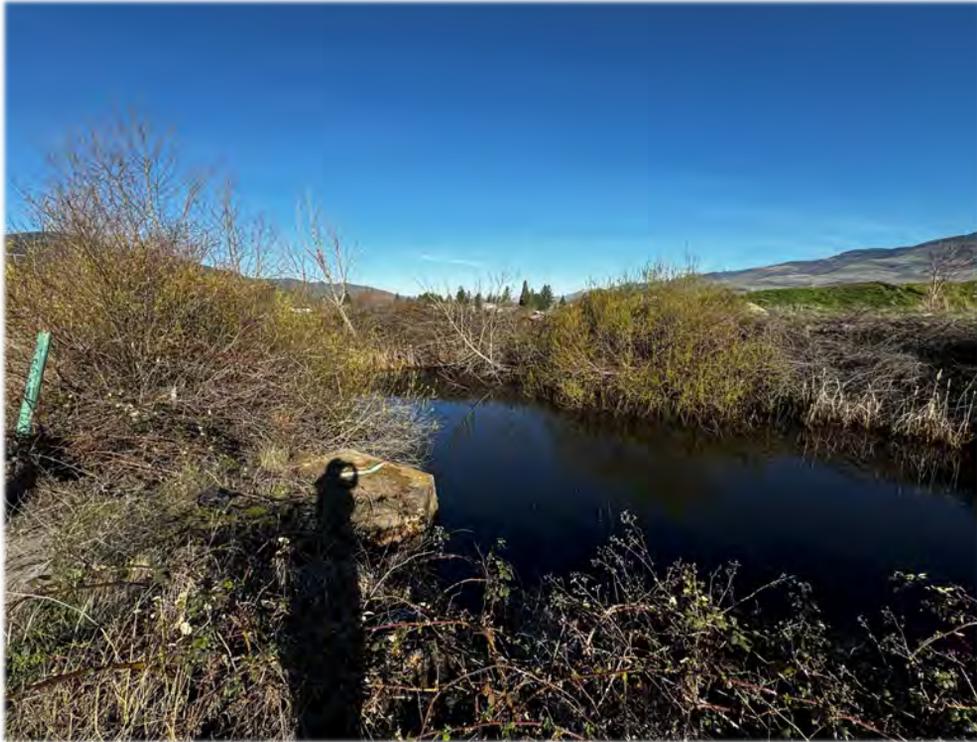
Photo Point 6. Facing northwest, showing man-made pond.

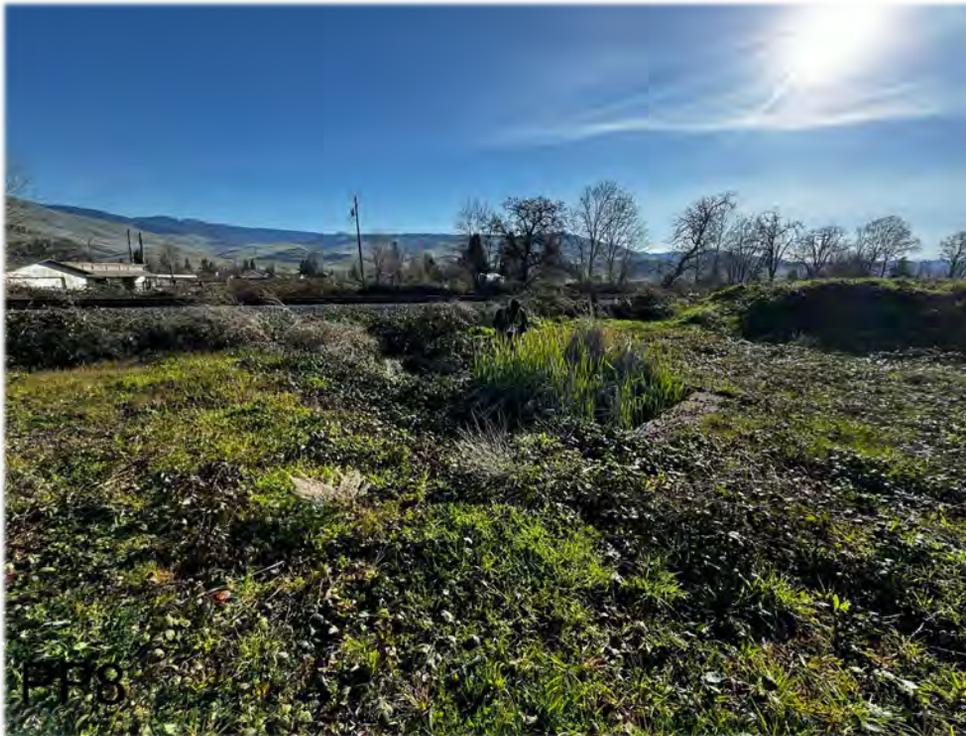
Photo Point 8. Facing east, showing Wetland 2.

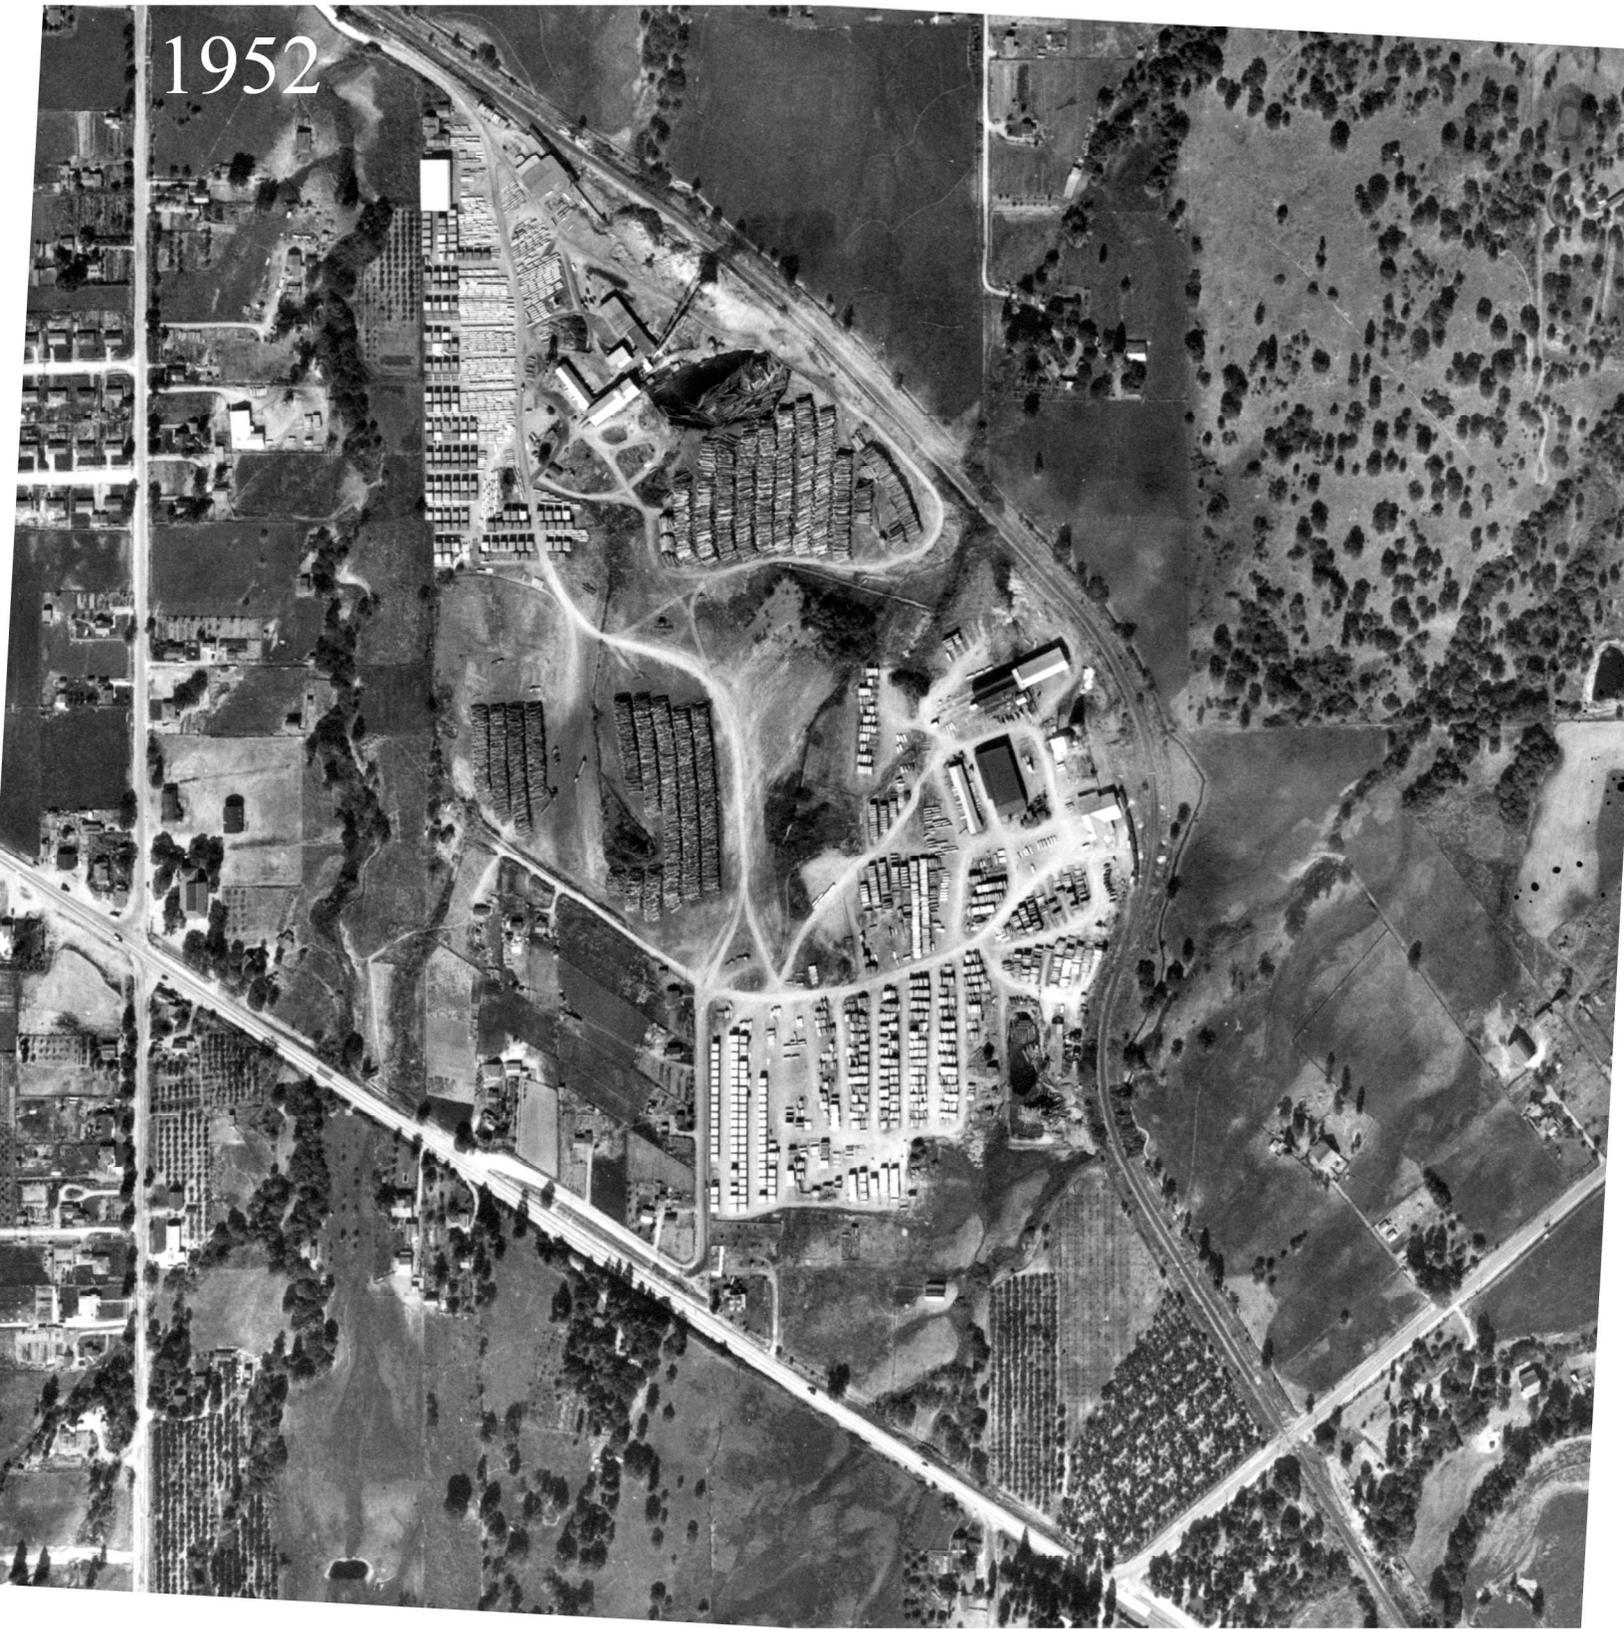
1952

- 1952: The site is operational as a sawmill with a few potential ditch connections observed in the middle of the site and a large pond in the northern portion of the site. The present-day pond (Pond 3; Figure 6) in the southeast corner of the site appears as more of a wetland drainage.

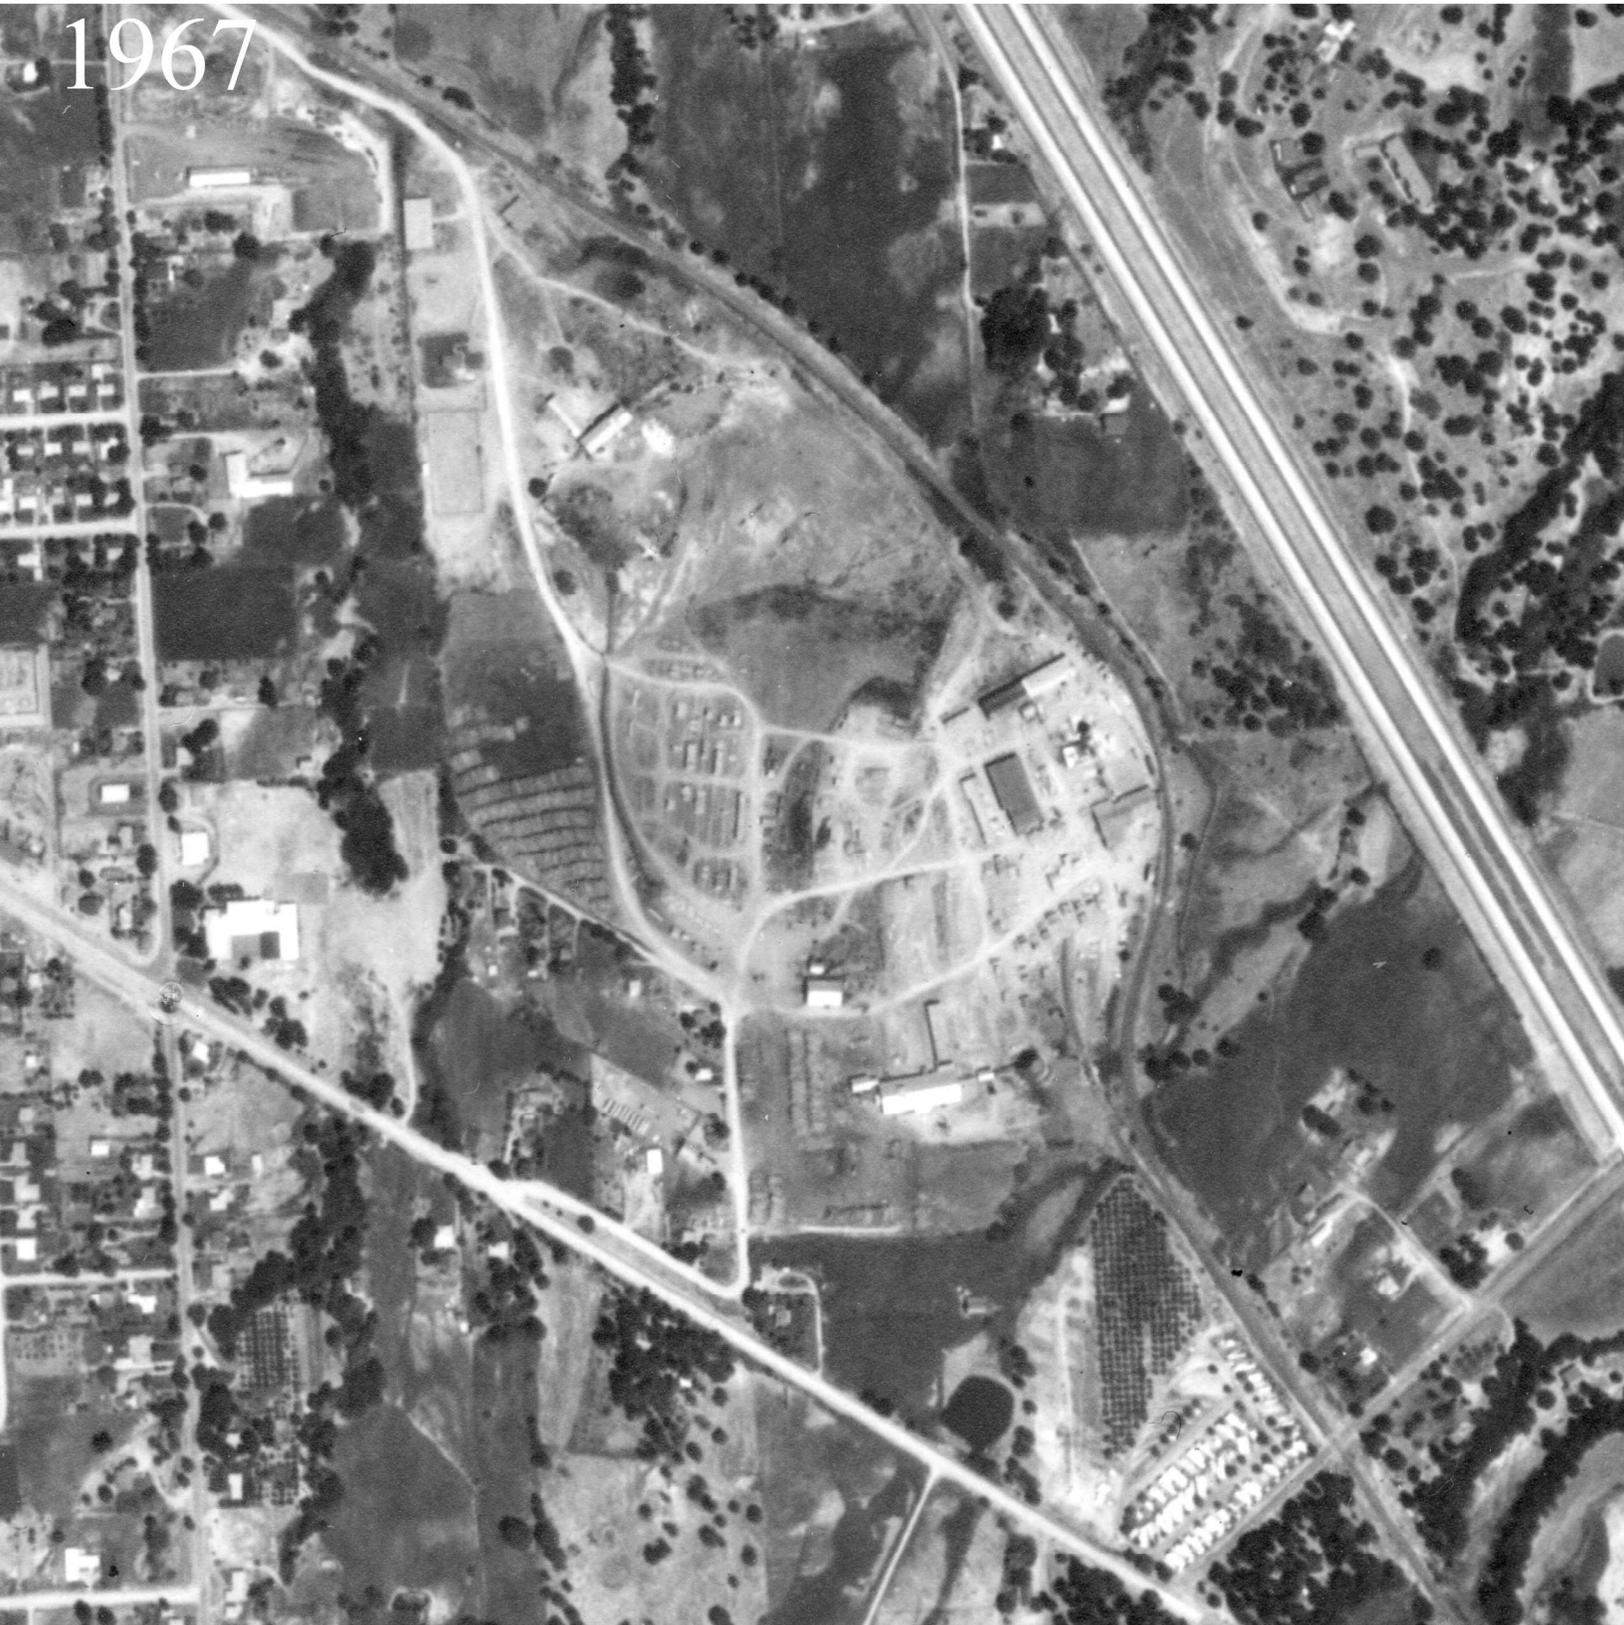
1967

- 1967: Site conditions are similar to 1952. Ponds 1, 2 and 4 do not appear to be present. Pond 3 evident in the aerial.
- 1976: The site is still heavily used as a sawmill with associated buildings. Drainages/ditches present in earlier photographs are largely removed. Only Pond 3 is evident.
