City of Ashland FCA

PUBLIC WORKS, PARKS, AND REC

ASHLAND, OR

JUNE 26, 2024

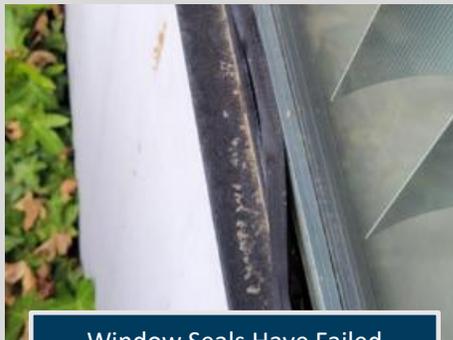
Window Seals Have Failed

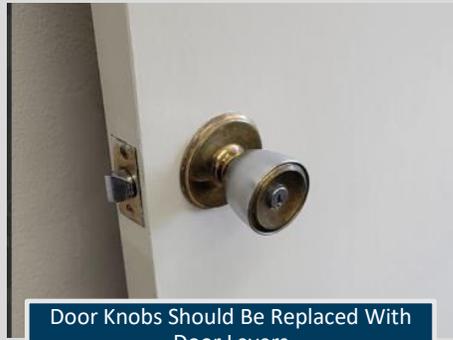
Door Knobs Should Be Replaced With Door Levers

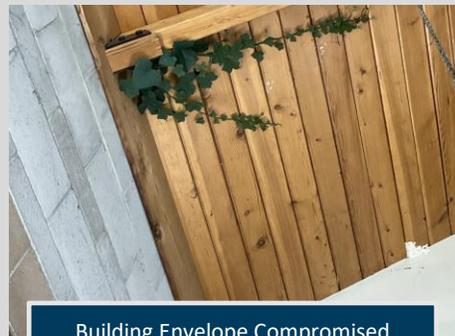
The building's CMU construction and metal roofing provide durability; however, the presence of plant life penetrating the roofline and entering the building signifies potential vulnerabilities in the building envelope. Remedial action is recommended to address roof maintenance and prevent further ingress of plant life, thereby preserving the integrity and safety of the restroom facility.

Building Envelope Compromised

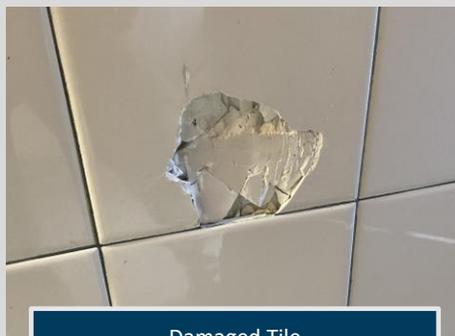
Damaged Tile

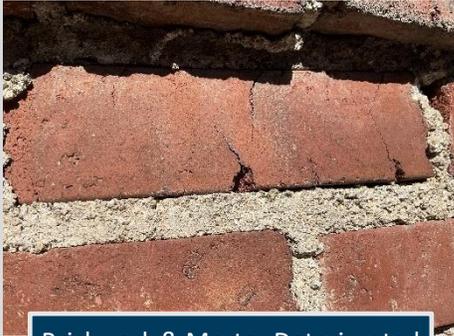
The building envelope exhibits significant structural deficiencies, including failures in the brickwork and mortar. Additionally, the roofing has exceeded its useful life, and windows installed across different decades require attention. Comprehensive repairs and replacements are essential to maintain the integrity and functionality of the building envelope.

Brickwork & Mortar Deteriorated

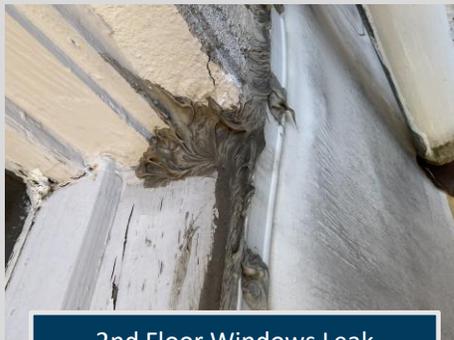
2nd Floor Windows Leak

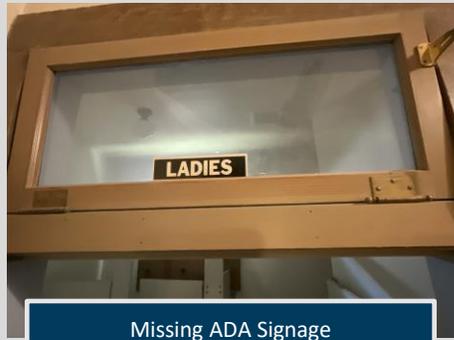
Missing ADA Signage

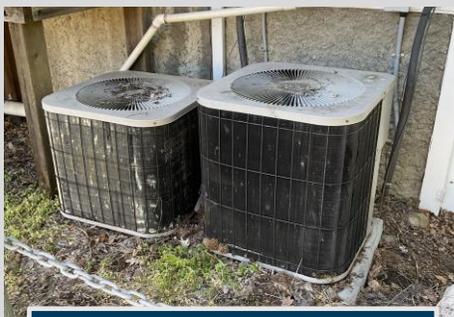
HVAC Equipment Past Useful Life

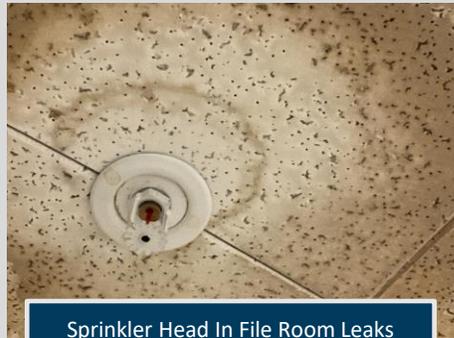
Sprinkler Head In File Room Leaks

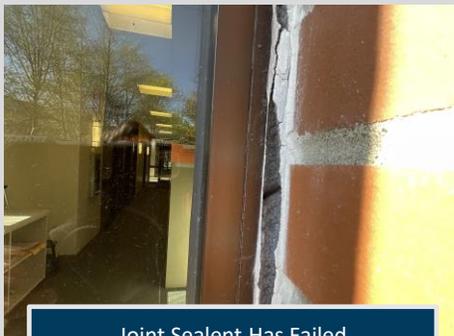
Joint Sealant Has Failed

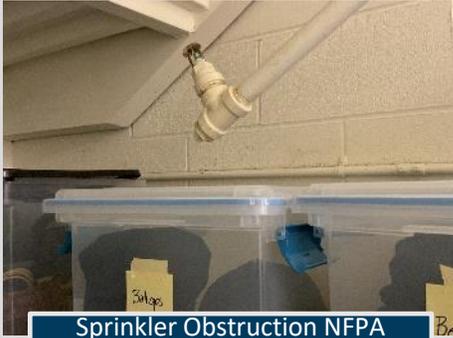
The fire alarm system, installed in 2003, requires attention due to the need for software/firmware updates or potential replacement to ensure compatibility with current standards and protocols. Additionally, multiple obstructions to sprinkler heads have been identified.

Sprinkler Obstruction NFPA Violation

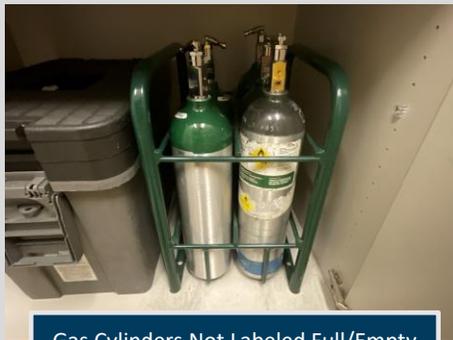
Gas Cylinders Not Labeled Full/Empty

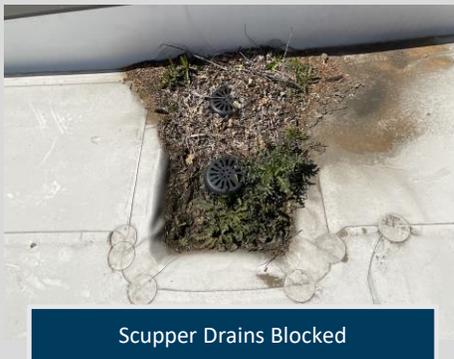
Scupper Drains Blocked

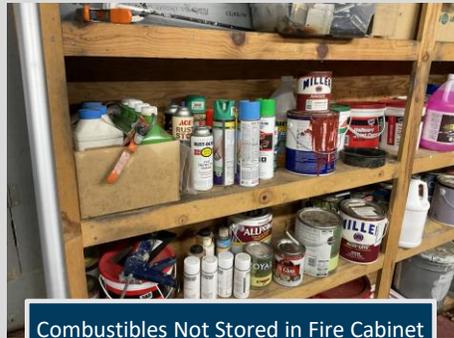
Combustibles Not Stored in Fire Cabinet

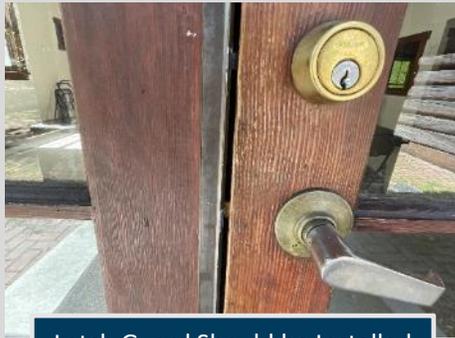
Latch Guard Should be Installed

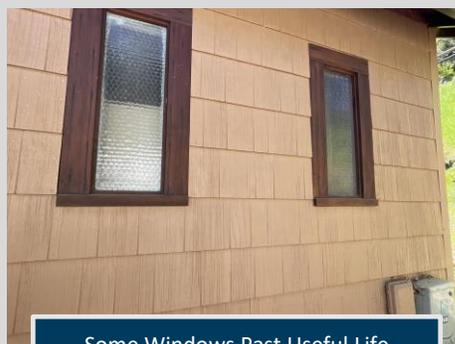
Most of the building features an original log cabin exterior wall, contributing to its historical significance. However, the roofing has surpassed its useful life and should be replaced to prevent water infiltration and structural damage. While most windows were replaced in 2009, further evaluation may be necessary to identify any structural issues and prioritize replacements or repairs as needed.

Some Windows Past Useful Life

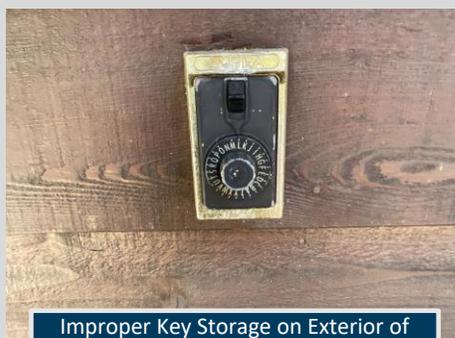
Improper Key Storage on Exterior of Building

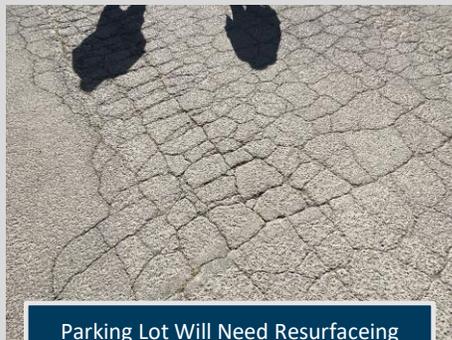
Parking Lot Will Need Resurfacing

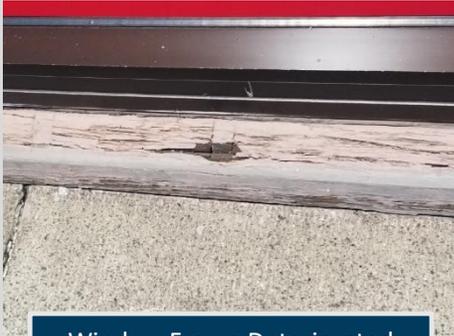
The building envelope is in adequate condition for its age, it is noted that the windows are far past useful life and should be scheduled for replacement.

Window Frame Deteriorated

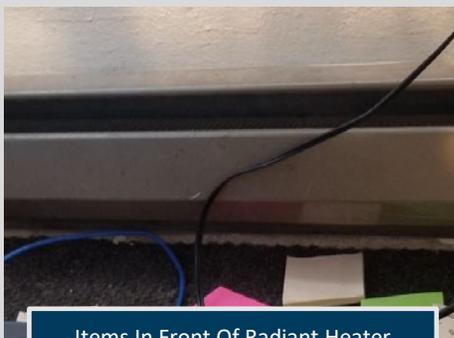
Items In Front Of Radiant Heater

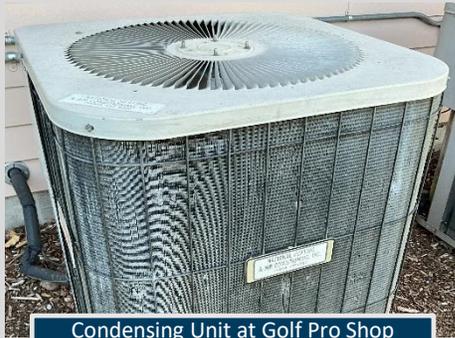
The majority of HVAC systems across this property found in the Maintenance Shop and the Golf Pro Shop were given a poor condition score due to their age. The exhaust fans have all surpassed their useful life expectancy and necessitate replacement. Both condensing units and gas furnaces within the Golf Pro shop have also exceeded their industry expected life and require replacement to continue to provide optimal comfort for occupants.

Condensing Unit at Golf Pro Shop Beyond Useful Life Expectancy.

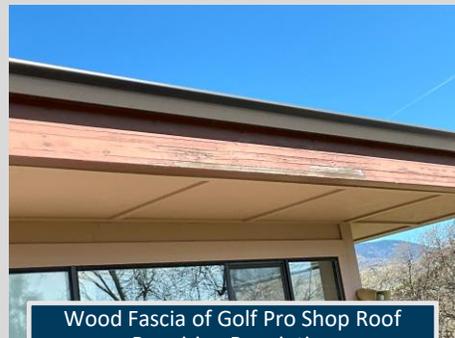
Most envelope components of the building are original, with minimal wear issues observed. However, the wood fascia and soffit of the roofs on the Golf Pro Shop and the Golf Cart Barn both display signs of weathering that necessitates attention and repainting to prevent dry rot. The golf cart barn additionally was observed with minimal debris in its gutters and some moss growing on its roof. The installation of gutter guards could extend the life of the gutters and therefore the building while also cutting costs associated with cleaning them. Minimal rust was observed on the metal frame of the doors to the exterior storage closet of the Maintenance shop, warranting attention.

Wood Fascia of Golf Pro Shop Roof Requiring Repainting

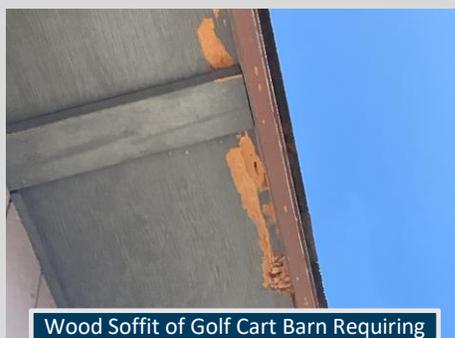
Wood Soffit of Golf Cart Barn Requiring Repair

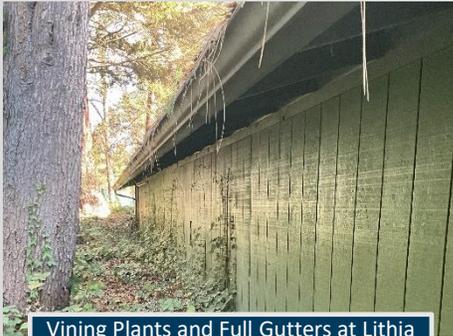
Most envelope components are in fair condition and within their industry useful life, but both the Lithia Park Shop and the Lithia Park Storage building roofs are in poor condition and due for replacement, Lithia Storage especially due to damage, dry rot, moss growth and asset age. Gutters were observed full of tree debris, indicating that gutter guards could be necessary to allow gutters to perform as designed. The exterior wood siding of the Lithia Park Storage building has also exceeded its industry expected life. Additionally, it is recommended to remove vining plants and moss on or near the exterior wood siding and foundation of the Lithia Park Material and Equipment Storage building to extend asset life.

Vining Plants and Full Gutters at Lithia Park Material and Equipment Storage

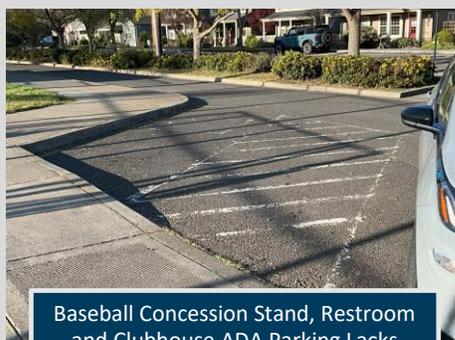
Where parking is available, the number of parking spaces for ADA requirements are considered sufficient, and all include van accessible spaces with adjoining access aisles. However, the paint in all lots is in poor condition, and all spots lack appropriate signage.

Baseball Concession Stand, Restroom and Clubhouse ADA Parking Lacks Signage

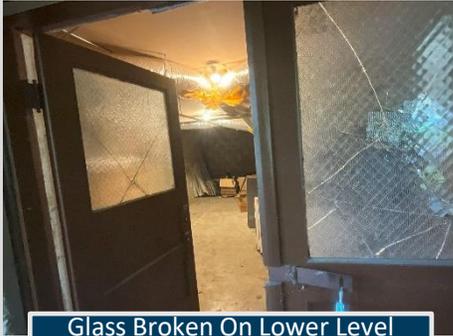
Glass Broken On Lower Level Storefront Exterior Doors

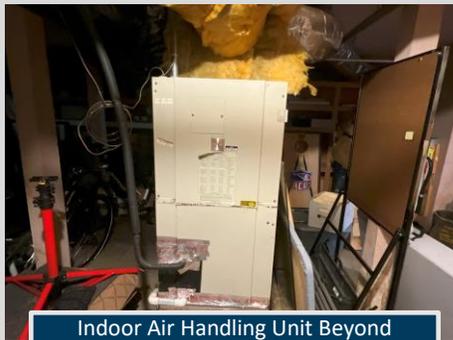
The electric condensing units, air handling units and radiant base board heaters have all exceeded their industry expected life and require replacement.

Indoor Air Handling Unit Beyond Industry Expected Life

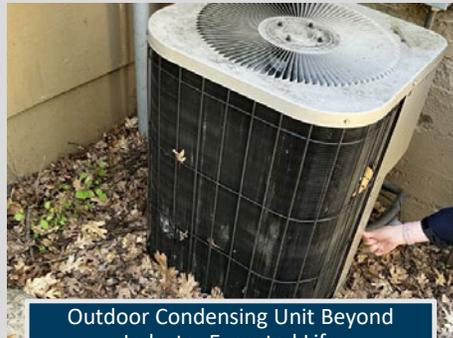
Outdoor Condensing Unit Beyond Industry Expected Life

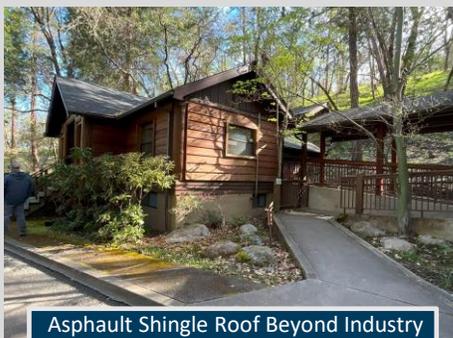
Most envelope components are in fair condition and exhibit minimal wear. However, the windows and asphalt shingle roof both require replacement due to exceeding their useful industry life.

Asphalt Shingle Roof Beyond Industry Expected Life

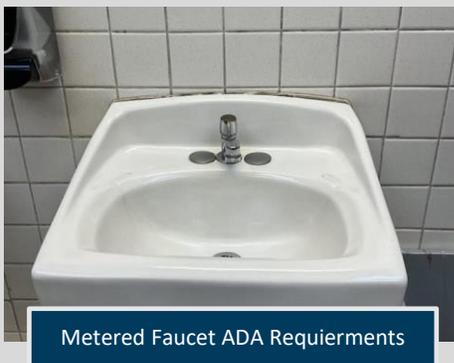
Metered Faucet ADA Requierments

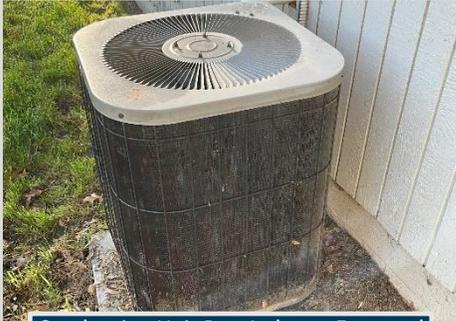
The HVAC systems within the Senior Center have all surpassed their industry expected life save for the air handler in the closet of office #105. Replacement of all other exhaust fans, split system condensing, and air handling units recommended.

Condensing Unit Past Industry Expected Life

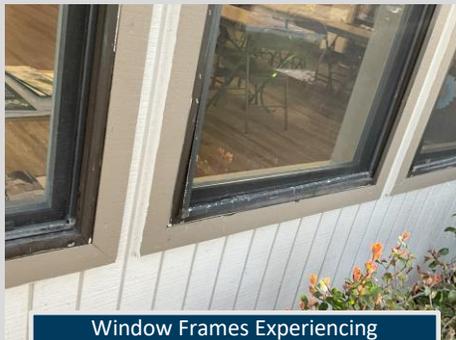
Overall, the envelope of the building is in fair condition, with the wood siding around the front windows and under the roof overhang only needing minimal attention to prevent entry of pests or further weathering. The roof has reached the end of its industry expected life, replacement recommended within the next 2 years.

Window Frames Experiencing Weathering
