**Facility Planning Optimization & Management Plan**  
for the City of Ashland, Oregon  
2025

# Facility Condition Assessment Executive Report

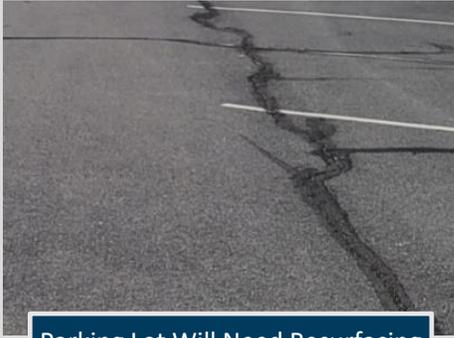
The parking lot currently meets the needs of the occupants adequately; however, resurfacing is recommended.

Parking Lot Will Need Resurfacing

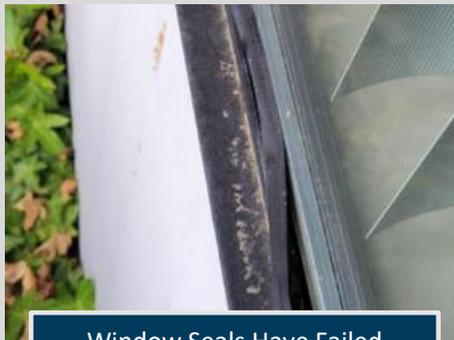
The building envelope is deemed adequate considering its age; however, the windows are significantly past their useful life and should be planned for replacement. Additionally, both the thermoplastic roofing and asphalt mansard roofing have exceeded their useful life and should be scheduled for replacement.

Window Seals Have Failed

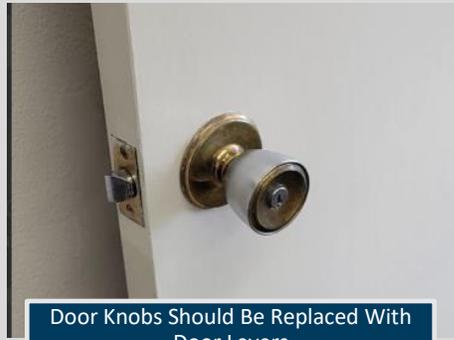
Door Knobs Should Be Replaced With Door Levers

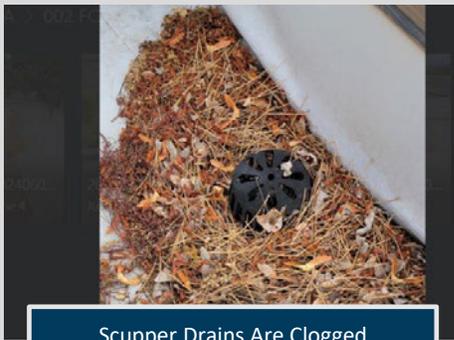
Scupper Drains Are Clogged

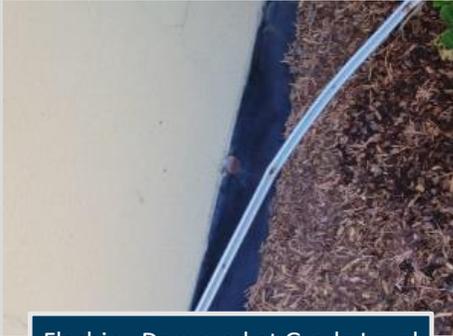
Flashing Damaged at Grade Level

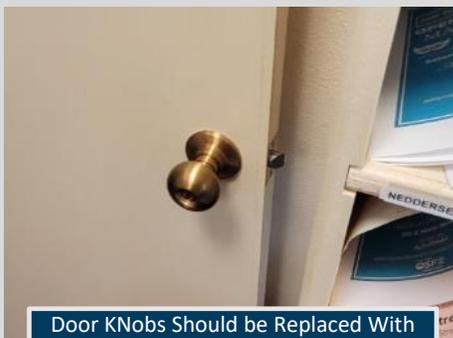
While most areas feature suitable accommodations, the current doorknobs need to be replaced with door levers to ensure accessibility. Furthermore, there is a deficiency in signage at inaccessible entrances, necessitating the installation of signage to direct individuals to accessible entry points.

Door KNobs Should be Replaced With Door Levers

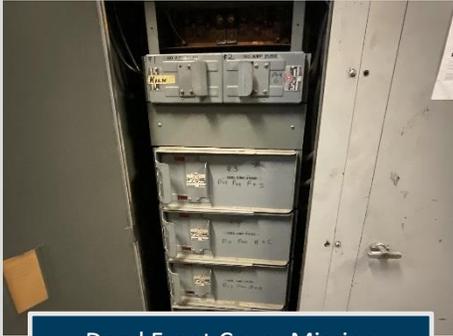
Dead Front Cover Missing

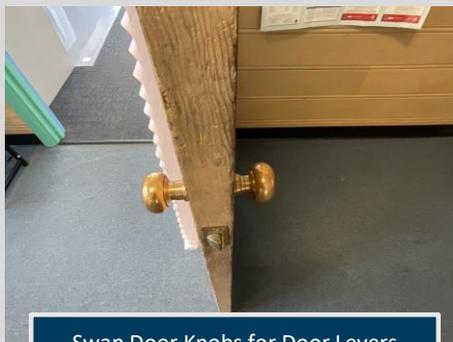
The ADA assessment reveals significant deficiencies, including the presence of doorknobs instead of levers, inaccessible main entrance, and missing signage. Recommendations include replacing doorknobs with levers, providing accessibility to the main entrance, and installing compliant signage to ensure equitable access for all occupants and visitors.

Swap Door Knobs for Door Levers

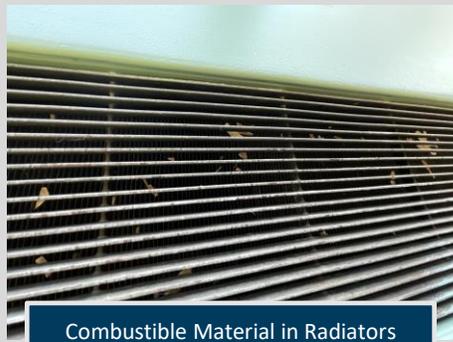
Combustible Material in Radiators

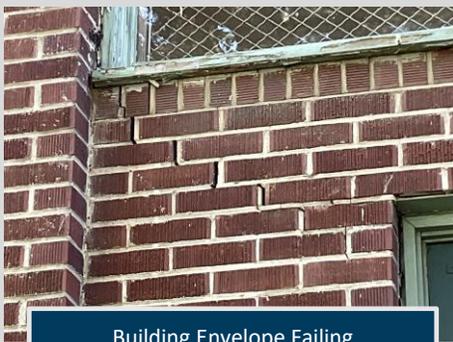
Original doors and windows dating back to the 1950s exhibit significant deterioration. Additionally, the northeast exterior wall of the gymnasium displays masonry failure, posing safety hazards and structural integrity concerns. Furthermore, the roofing system has surpassed its useful life, leading to pervasive leaks and moisture intrusion throughout the building.

Building Envelope Failing

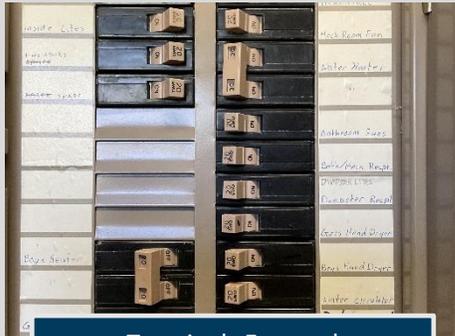
Terminals Exposed

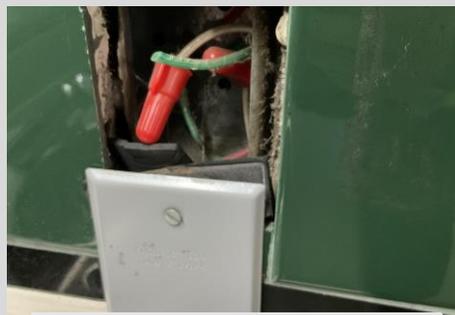
J-box Open Exposed Wires in Both Rest Rooms

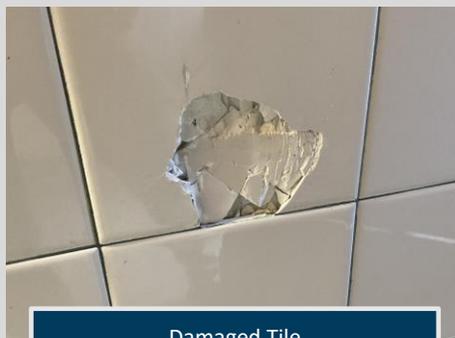
Damaged Tile

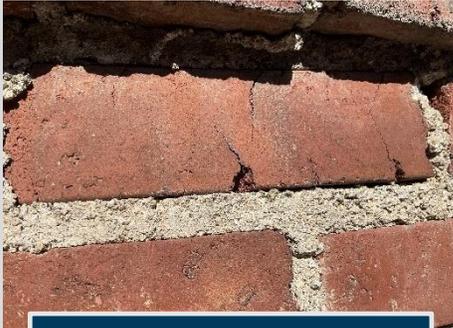
The building envelope exhibits significant structural deficiencies, including failures in the brickwork and mortar. Additionally, the roofing has exceeded its useful life, and windows installed across different decades require attention. Comprehensive repairs and replacements are essential to maintain the integrity and functionality of the building envelope.

Brickwork & Mortar Deteriorated

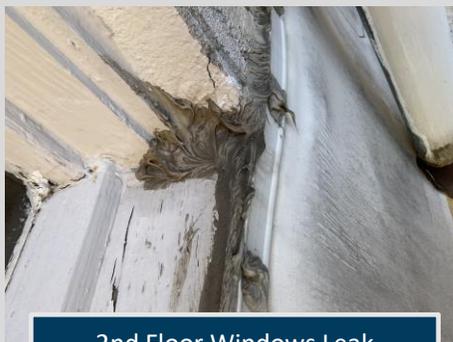
2nd Floor Windows Leak

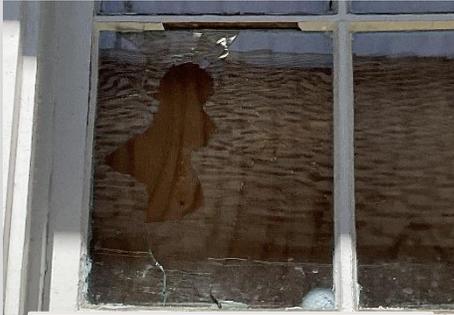
The building's envelope is predominantly original construction (1920), with subsequent installation of the roof in 1996. The windows are in a deteriorated state, with some boarded up and damaged. Repairing or replacing the windows and roof is recommended to enhance energy efficiency, aesthetics, and structural integrity.

Single Pane Windows Damaged

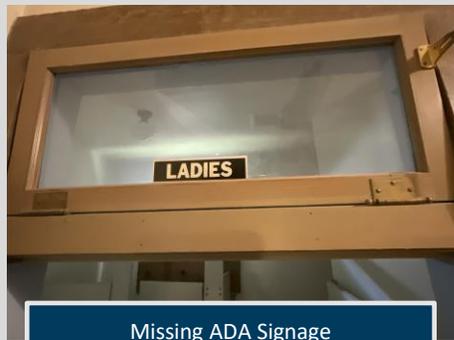
Missing ADA Signage

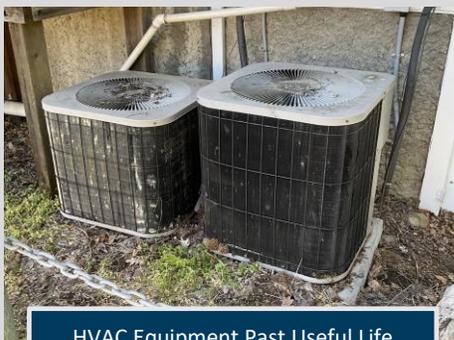
HVAC Equipment Past Useful Life

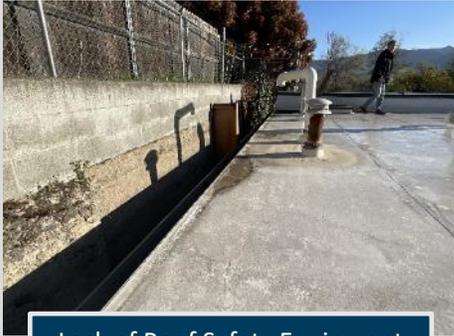
Lack of Roof Safety Equipment

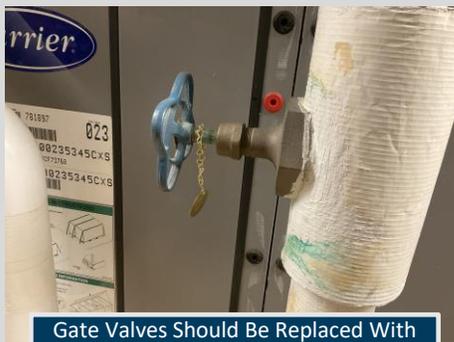
Gate Valves Should Be Replaced With Ball Valves

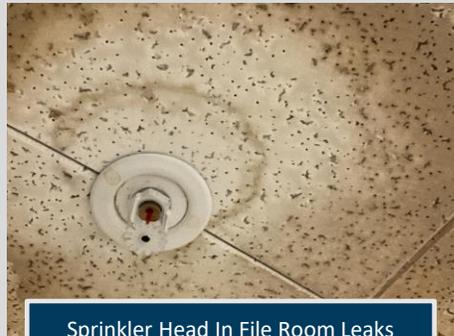
Sprinkler Head In File Room Leaks

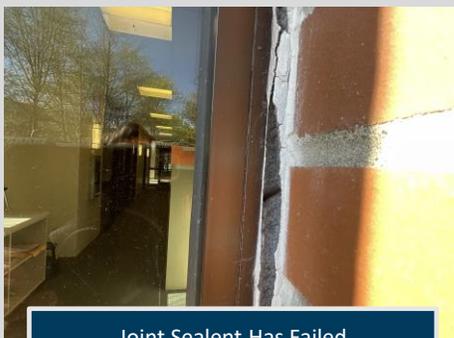
Joint Sealant Has Failed

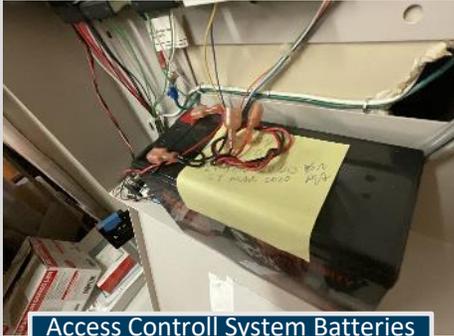
Access Control System Batteries Should be Replaced.

It is recommended to replace the batteries in access control systems as they have expired. Installation of door latch or door jamb guards would be prudent to enhance security measures and prevent unauthorized access.

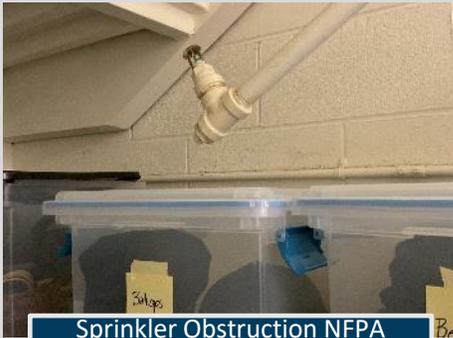
The fire alarm system, installed in 2003, requires attention due to the need for software/firmware updates or potential replacement to ensure compatibility with current standards and protocols. Additionally, multiple obstructions to sprinkler heads have been identified.

Sprinkler Obstruction NFPA Violation

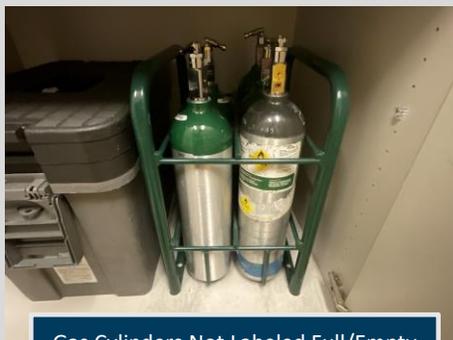
Gas Cylinders Not Labeled Full/Empty

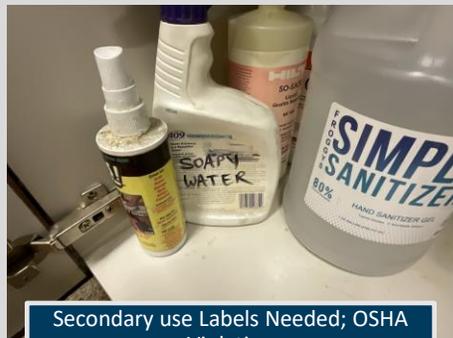
Secondary use Labels Needed; OSHA Violation

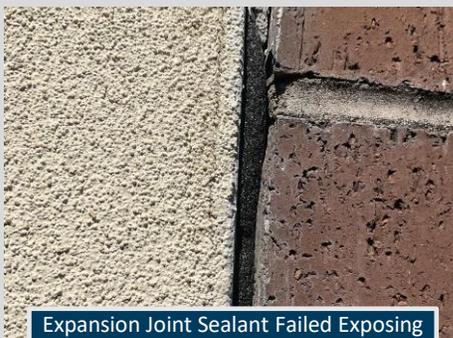
Apart from the failing joint sealant, the building envelope is adequate. Nonetheless, plans should be made to replace the TPO roofing system to maintain structural integrity and weather resistance.

Expansion Joint Sealant Failed Exposing Backer Rod

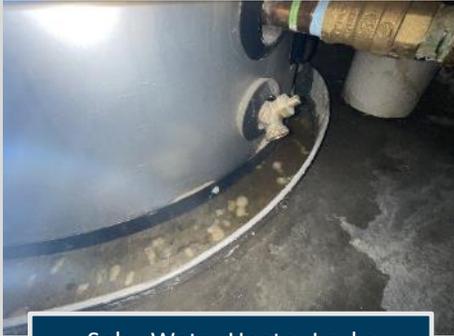
Solar Water Heater Leaks

The hot water system is supplemented with solar technology, reflecting a commitment to sustainability. However, there are concerns regarding a leaking solar water tank, necessitating repairs or replacement to optimize system efficiency and prevent water damage.

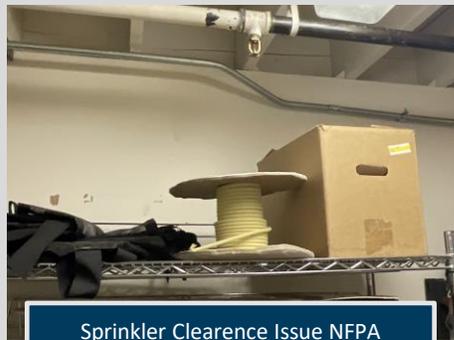
Sprinkler Clearance Issue NFPA

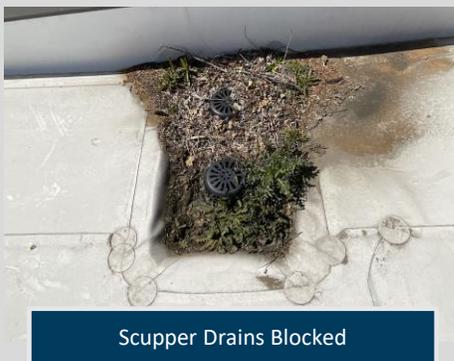
Scupper Drains Blocked

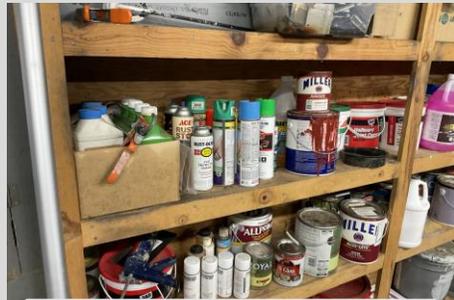
Combustibles Not Stored in Fire Cabinet

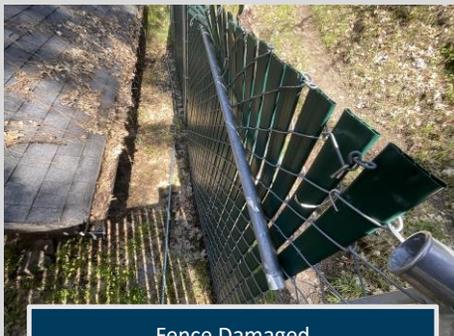
Fence Damaged

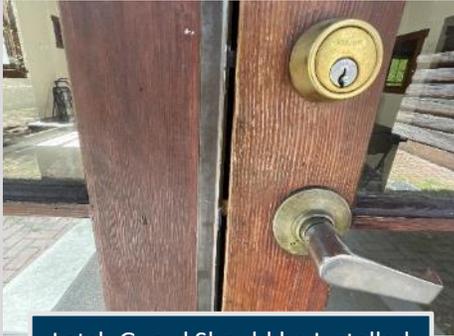
Latch Guard Should be Installed

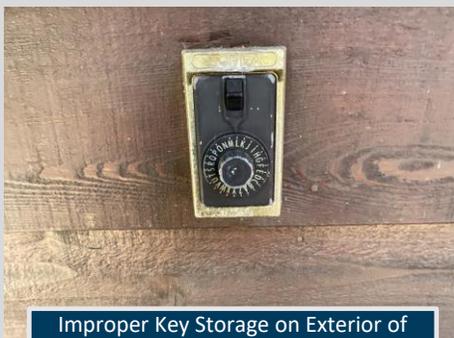
Improper Key Storage on Exterior of Building

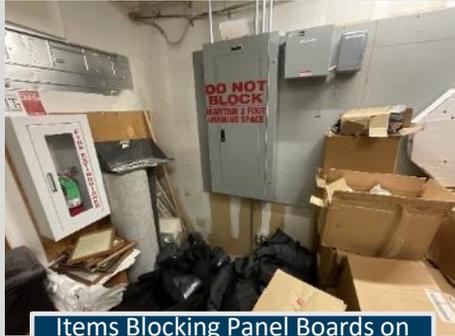
Items Blocking Panel Boards on 2nd Floor

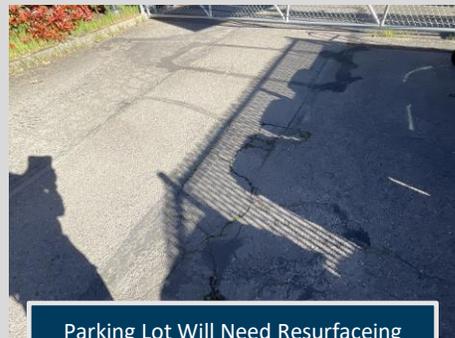
Parking Lot Will Need Resurfacing

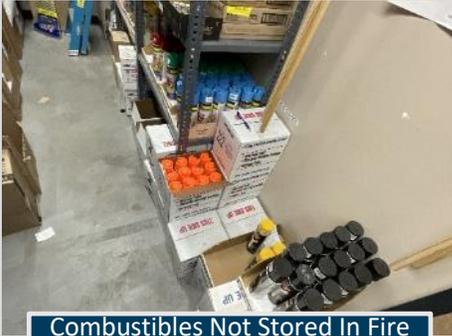
Combustibles Not Stored In Fire Cabinet

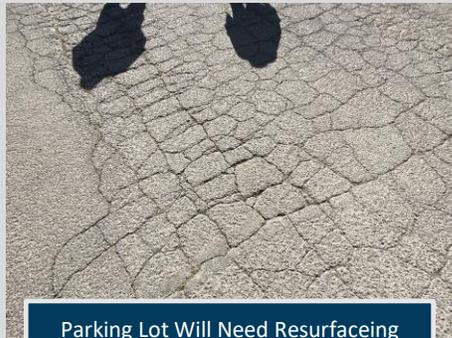
The parking lot requires resurfacing to address wear and tear and maintain a safe and functional parking area. ADA parking requirements are currently met, ensuring accessibility for individuals with disabilities.

Parking Lot Will Need Resurfacing

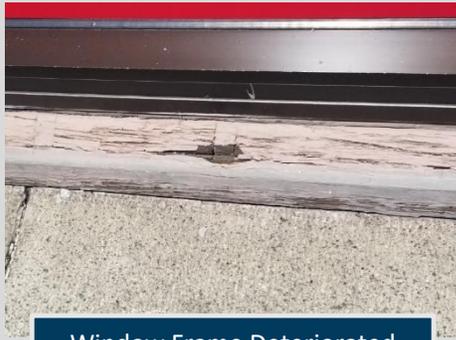
The building envelope is in adequate condition for its age, it is noted that the windows are far past useful life and should be scheduled for replacement.

Window Frame Deteriorated

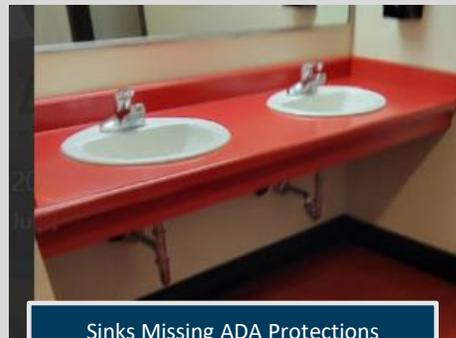
The ADA inspection reveals several compliance issues: all sinks lack proper plumbing protections, doorknobs need to be replaced with door levers, ADA signage is missing from accessible entrances, and directional signage is absent from inaccessible entrances to guide individuals to accessible entrances.

Sinks Missing ADA Protections

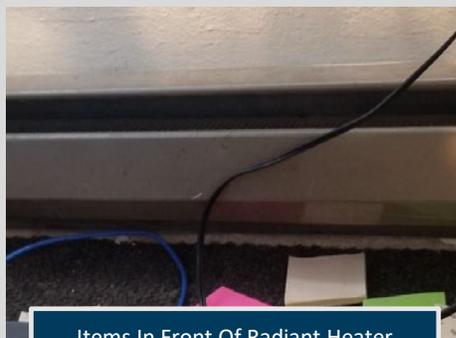
Items In Front Of Radiant Heater

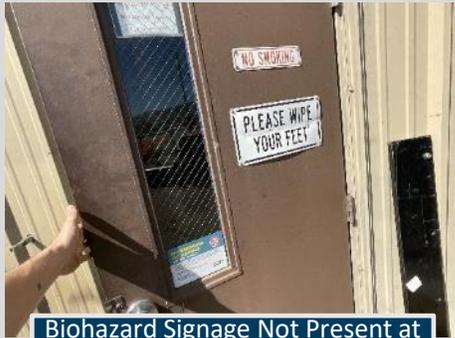
Biohazard Signage Not Present at Welding Shop

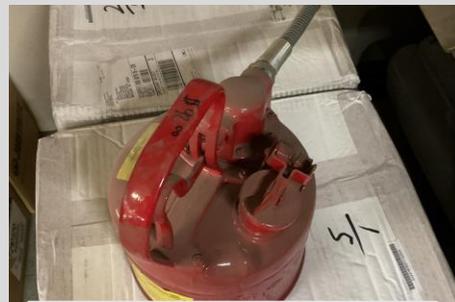
Combustibles Not Stored in Fire Cabinet

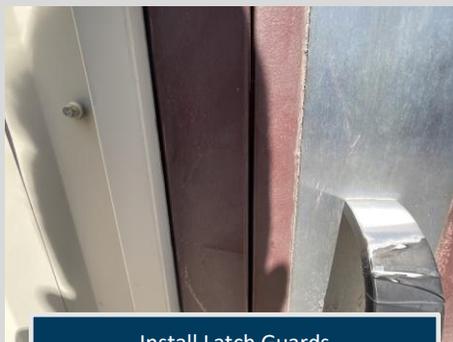
Install Latch Guards

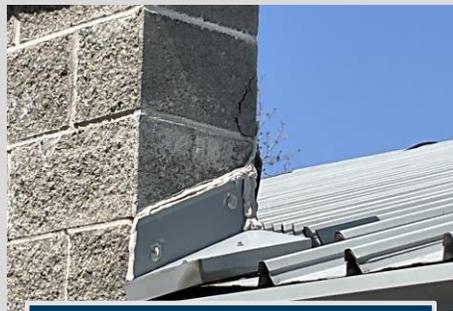
Flashing Needs Replacement

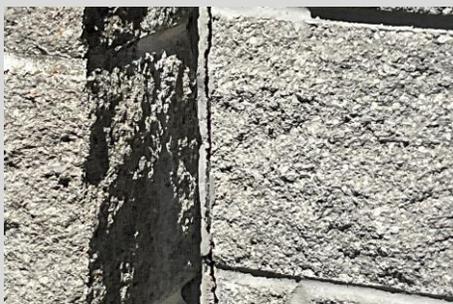
Despite damage to the CMU joint at the south entrance, the metal roof and siding remain well within their useful life. Prioritizing repairs to the damaged joint preserves the structural integrity of the building and prevents further deterioration. Maintaining the building envelope is essential to safeguarding occupants, protecting against weather elements, and prolonging the lifespan of the property.

Damage at Southern Entrance

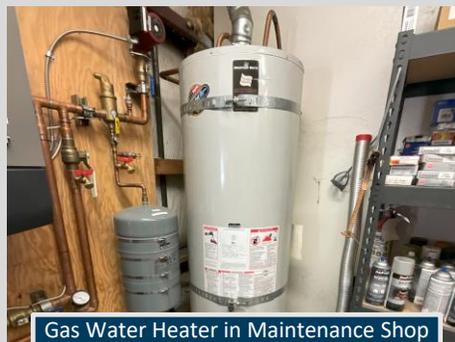
Plumbing systems were minimal throughout the buildings, although the natural gas water heater within the Maintenance Shop has exceeded its useful industry life and requires replacement.

Gas Water Heater in Maintenance Shop Beyond Useful Life Expectancy

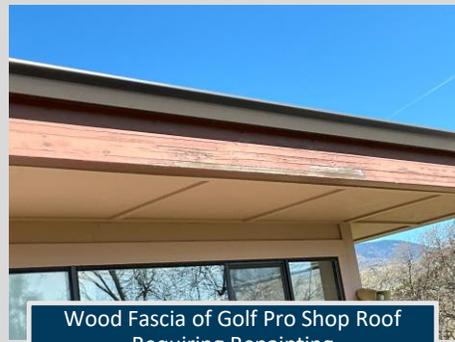
Wood Fascia of Golf Pro Shop Roof Requiring Repainting

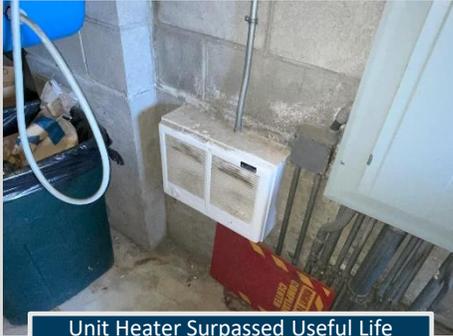
Unit Heater Surpassed Useful Life Expectancy

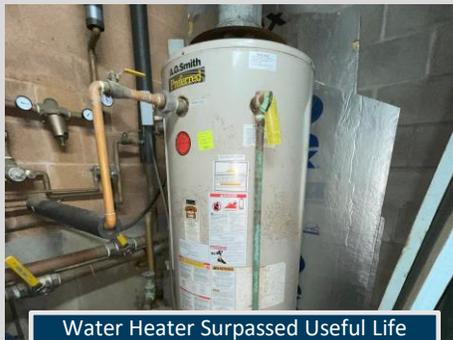
Water Heater Surpassed Useful Life Expectancy

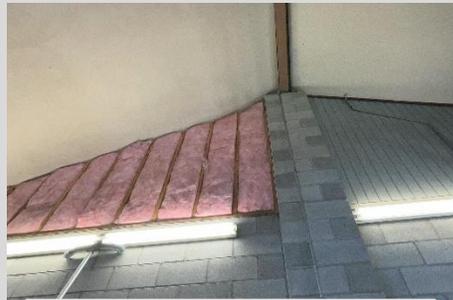
The building envelope is primarily in fair condition, with most assets within their industry expected life. However, the metal doors are beyond their useful expected life with some visible wear due to age and outdated hardware. Replacement recommended. Within the mechanical basement, there is exposed insulation on near the vaulted ceiling one on side, and a hole in the drywall ceiling above the doors that both necessitate attention.

Exposed insulation in Mechanical Room

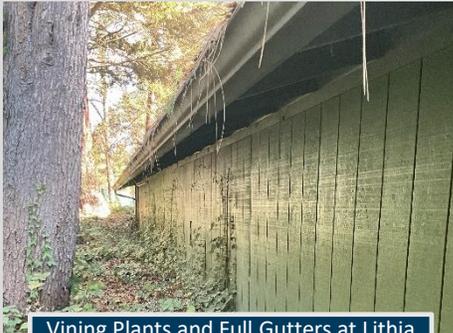
Vining Plants and Full Gutters at Lithia Park Material and Equipment Storage

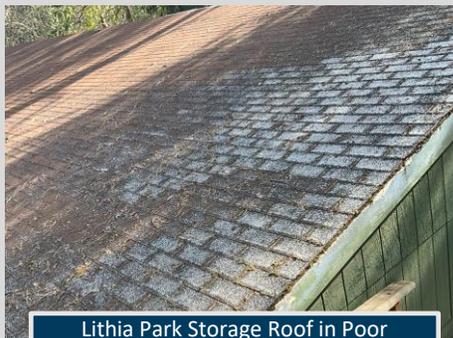
Most envelope components are in fair condition and within their industry useful life, but both the Lithia Park Shop and the Lithia Park Storage building roofs are in poor condition and due for replacement, Lithia Storage especially due to damage, dry rot, moss growth and asset age. Gutters were observed full of tree debris, indicating that gutter guards could be necessary to allow gutters to perform as designed. The exterior wood siding of the Lithia Park Storage building has also exceeded its industry expected life. Additionally, it is recommended to remove vining plants and moss on or near the exterior wood siding and foundation of the Lithia Park Material and Equipment Storage building to extend asset life.

Lithia Park Storage Roof in Poor Condition

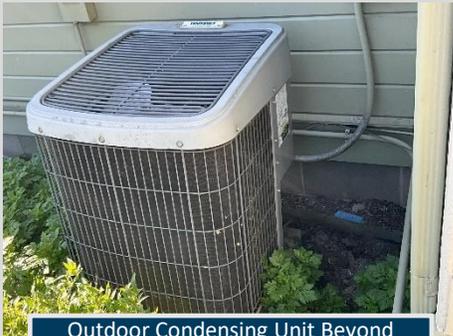
All the HVAC systems in the building have surpassed their industry useful life and require replacement. Electric split system air handling units are used to condition this space.

Outdoor Condensing Unit Beyond Industry Expected Life

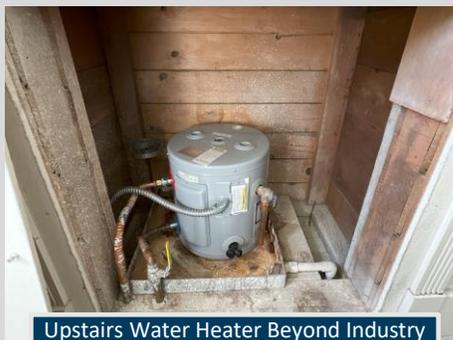
The electric water heater in the upstairs restroom that serves the building has reached the end of the expected industry life and requires replacement.

Upstairs Water Heater Beyond Industry Expected Life

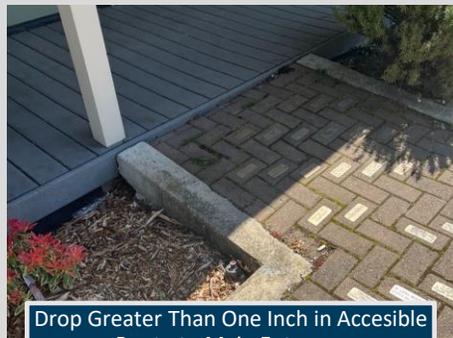
Drop Greater Than One Inch in Accessible Route to Main Entrance

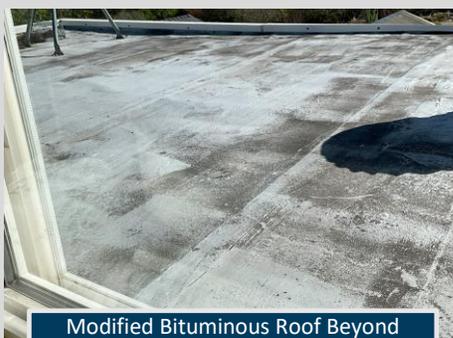
Most envelope components of the building are in fair condition with minimal wear issues observed. However, both the asphalt shingle and modified bituminous flat roof have reached the end of their useful industry life and require replacement to protect building integrity. The windows were notably newer than the building and in fair condition.

Modified Bituminous Roof Beyond Industry Expected Life.

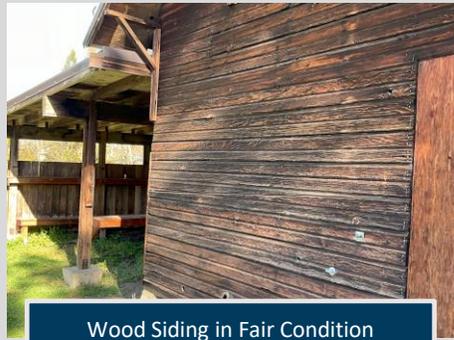
Wood Siding in Fair Condition

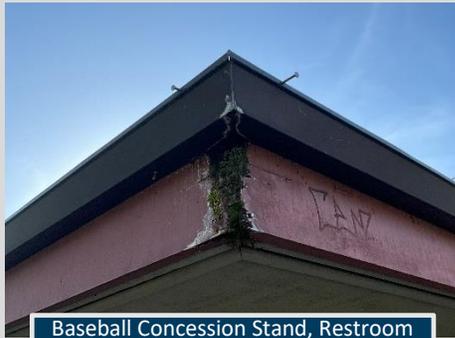
The roofs of all buildings are due for replacement due to age, and the roof fascia of all buildings except the Baseball Batting Cages and Storage is rotting in some corners, necessitating repair or replacement to protect the structural integrity of the buildings. Additionally, the windows of the Softball Material and Equipment Storage building have exceeded their industry expected life.

Baseball Concession Stand, Restroom and Clubhouse Roof Fascia Rotting

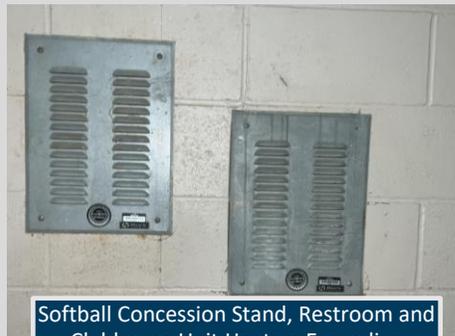
The HVAC systems across all buildings have surpassed their useful life expectancy and require replacement to provide optimal environments for building occupants. While electric unit heaters are used to heat the Baseball and Softball restrooms, concession stands, and clubhouses, ductless split systems are used to condition the Softball Material and Equipment Storage building.

Softball Concession Stand, Restroom and Clubhouse Unit Heaters Exceeding Useful Life

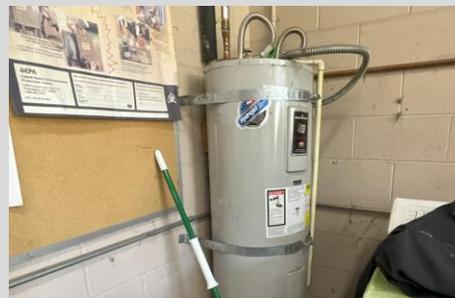
All the electrical water heaters within the buildings have exceeded their useful life expectancy, warranting attention for replacement.

Softball Material and Equipment Storage Water Heater Exceeding Useful Life

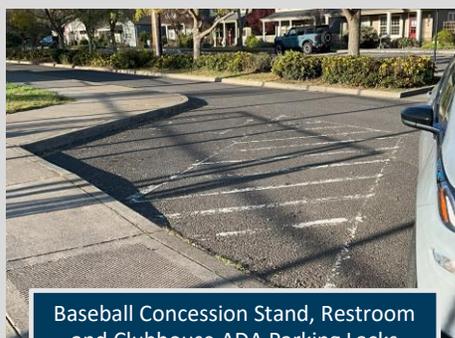
Where parking is available, the number of parking spaces for ADA requirements are considered sufficient, and all include van accessible spaces with adjoining access aisles. However, the paint in all lots is in poor condition, and all spots lack appropriate signage.

Baseball Concession Stand, Restroom and Clubhouse ADA Parking Lacks Signage

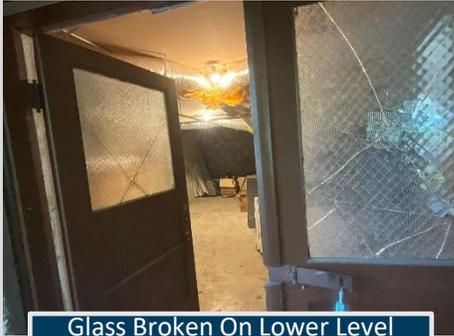
Glass Broken On Lower Level Storefront Exterior Doors

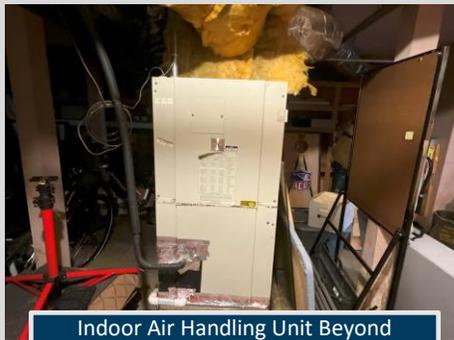
The electric condensing units, air handling units and radiant base board heaters have all exceeded their industry expected life and require replacement.

Indoor Air Handling Unit Beyond Industry Expected Life

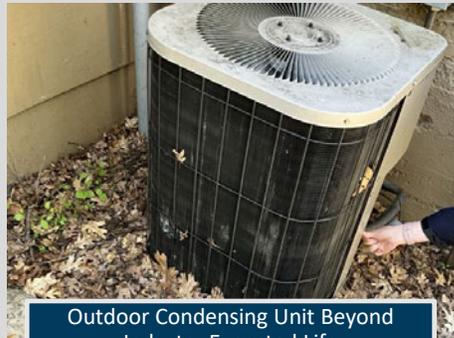
Outdoor Condensing Unit Beyond Industry Expected Life

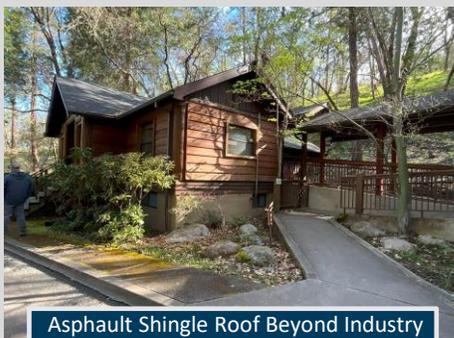
Most envelope components are in fair condition and exhibit minimal wear. However, the windows and asphalt shingle roof both require replacement due to exceeding their useful industry life.

Asphalt Shingle Roof Beyond Industry Expected Life

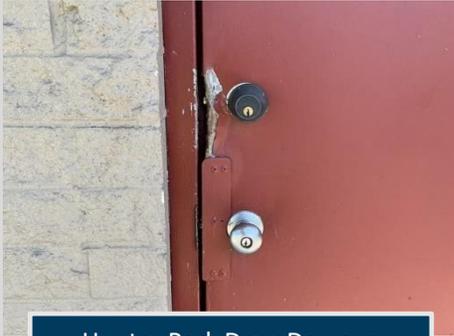
Hunter Park Door Damage

Most envelope components of the restrooms are original, with minimal wear issues observed. However, the door at Hunter Park has sustained forced entry damage and necessitates replacement. Other doors may require hardware replacements. Siding is generally adequate with moderate wear, although the swim reservoir restroom's metal siding shows signs of rust and deterioration. Roofing systems across several buildings, including The Dog Park, Garden Way, Garfield, Lithia Playground, Parks Admin Public Rest Room, Railroad, and the Skate Park, require replacement due to aging. Considering minimal usage, the recommendation is to install metal roofing systems for longevity and durability.

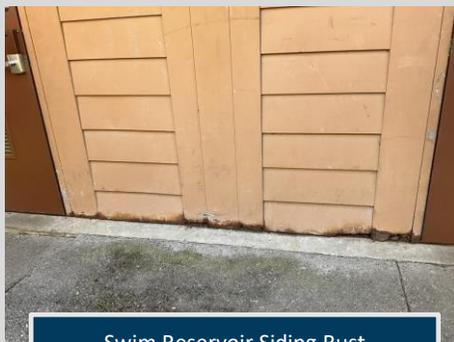
Swim Reservoir Siding Rust

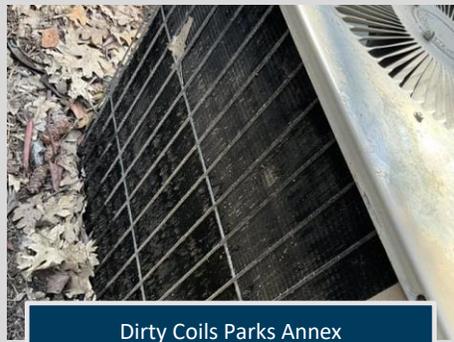
Dirty Coils Parks Annex

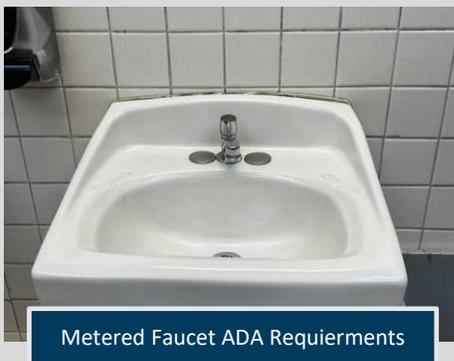
Metered Faucet ADA Requierments

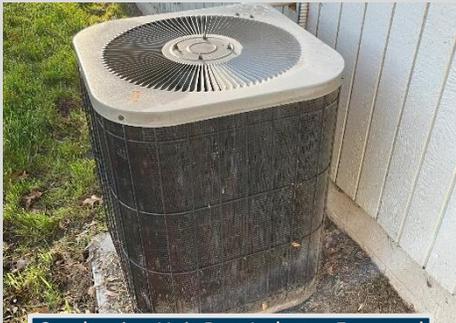
The HVAC systems within the Senior Center have all surpassed their industry expected life save for the air handler in the closet of office #105. Replacement of all other exhaust fans, split system condensing, and air handling units recommended.

Condensing Unit Past Industry Expected Life

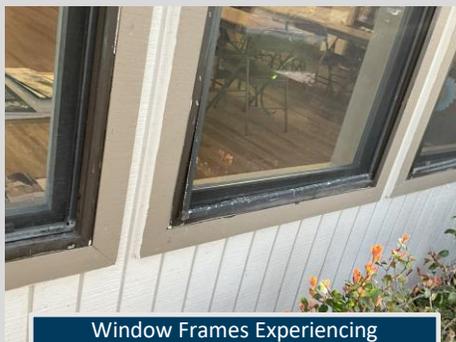
Window Frames Experiencing Weathering
